Tomb of Jam Nizam Al Din

Makli World Heritage Site

Structural Damage assessment and recommended consolidation measures

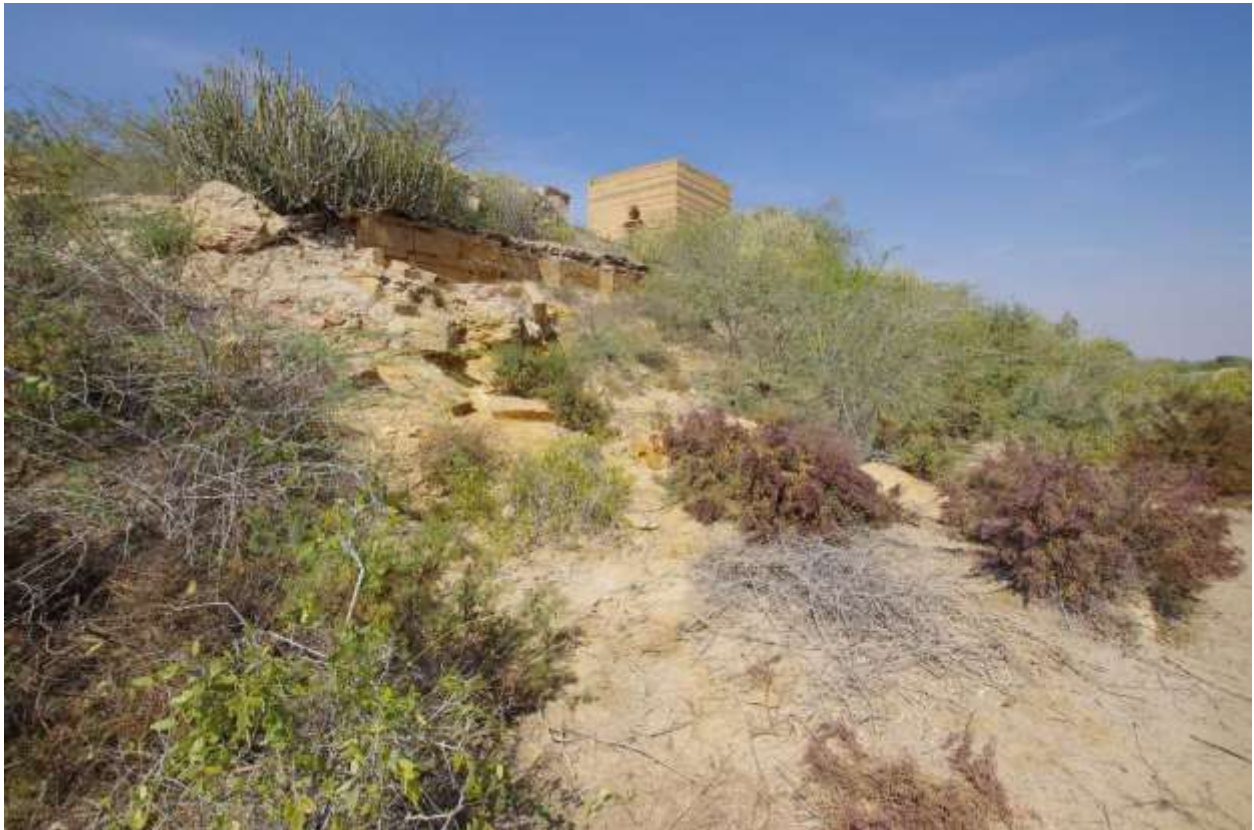
The term “shale” is used by ces to identify “dense silt”, a clayish loam with markedly plastic behaviour. The physical properties of the material change if inundated or exposed to water for a longer period. In this instance, the stiffness of the material decreases noticeably. Furthermore, if exposed to the weather, this material can deteriorate and disintegrate quite rapidly. The erosion process of the cliff was already described by ces in their final report: since the soft layer of loam erodes quite quickly under atmospheric exposure, it leads to the landslip of the limestone layer above. The ongoing erosion of the bluff can be witnessed at the example of a sepulchral structure below Jam Nizam al Din, which has been partly carried away due to the ongoing degradation of the slope (See image 7).

Image 7: Remnants of a tomb structure south-east of Jam Nizam al Din. The structure collapsed due to the erosion of the slope.

In order to secure the cliff area against further erosion, a comprehensive solution needs to be developed. For this purpose, a geotechnical slope stabilization with granular filters (and geotextiles) needs to be designed. This measure should protect both, the rim of the bluff as well as the bottom of the cliff in case of flooding of the riverbed. Although the erosion problem is most acute at the tomb of Jam Nizam al Din, it can also be noticed at many other locations along the cliff.

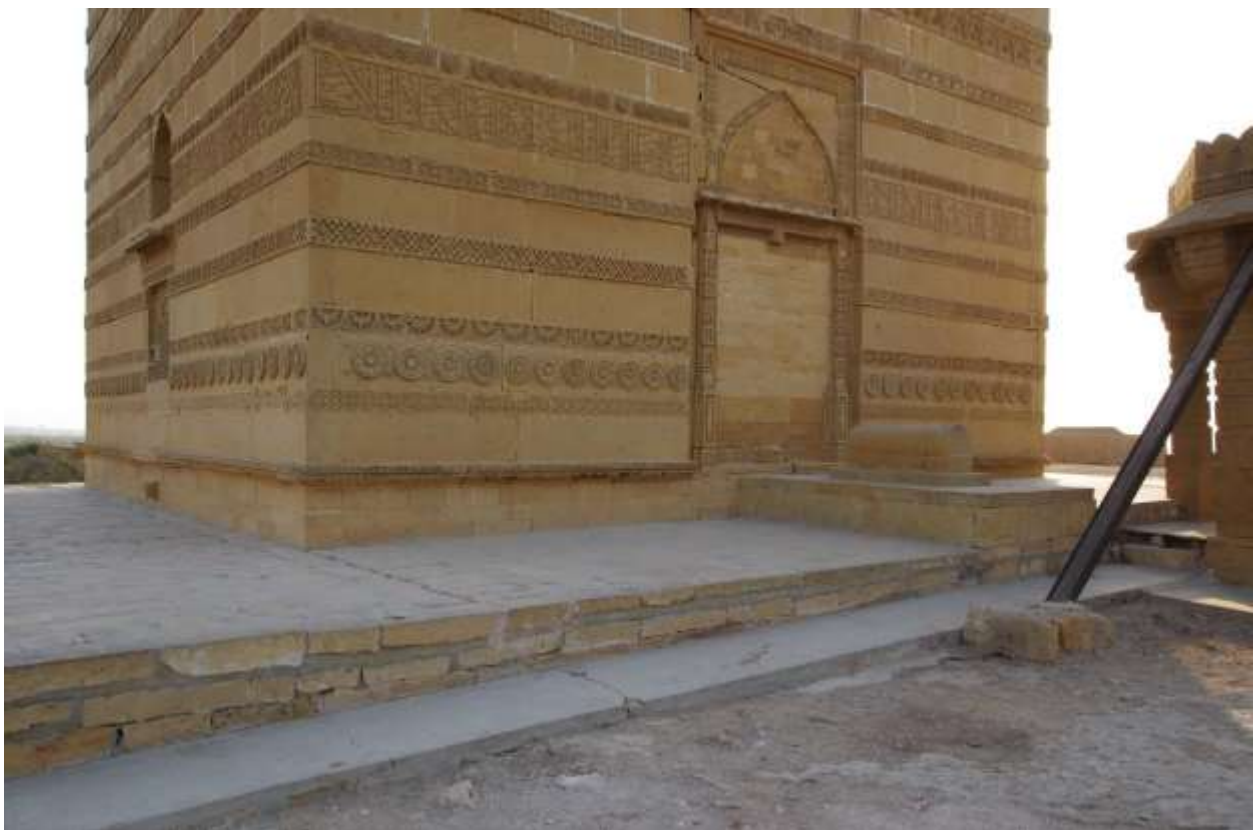
Image 10: North-eastern corner of the building with the masonry encased retaining wall installed in 1994 and (in the foreground) the concrete apron installed in 1996.

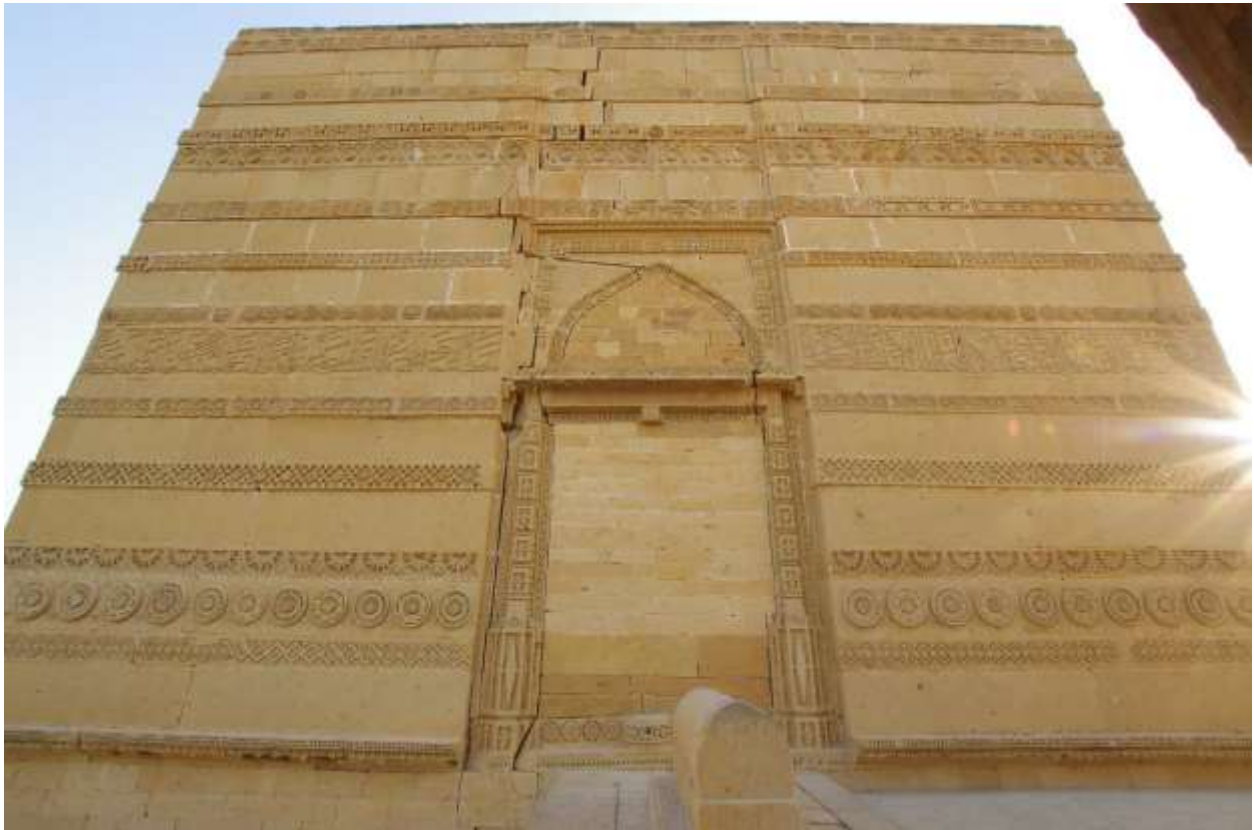
The south and north wall of the tomb show serious dislodgements of the dressed stone masonry. The subsidence of the eastern part of the building caused an uneven overall settlement of the structure, leading to severe perturbations of the stone masonry above. The history of the formation of cracks and dislodgements due to subsidence can be followed very clearly at the centres of the south and north wall. Here, the positioning of the door and window openings in the symmetry axis of the massive masonry walls created a weak point in the structure that acts like a hinge within the structure. Whereas the western half of the building remains stable, the eastern half of the building suffers from continuing subsidence and horizontal movement of the ground. Consequently, cracks and horizontal gaps in the masonry propagate upwards in the symmetry lines of the south and north wall.

Image 11: North facade of Jam Nizam al Din, showing the sealed northern doorway and the series of cracks above.

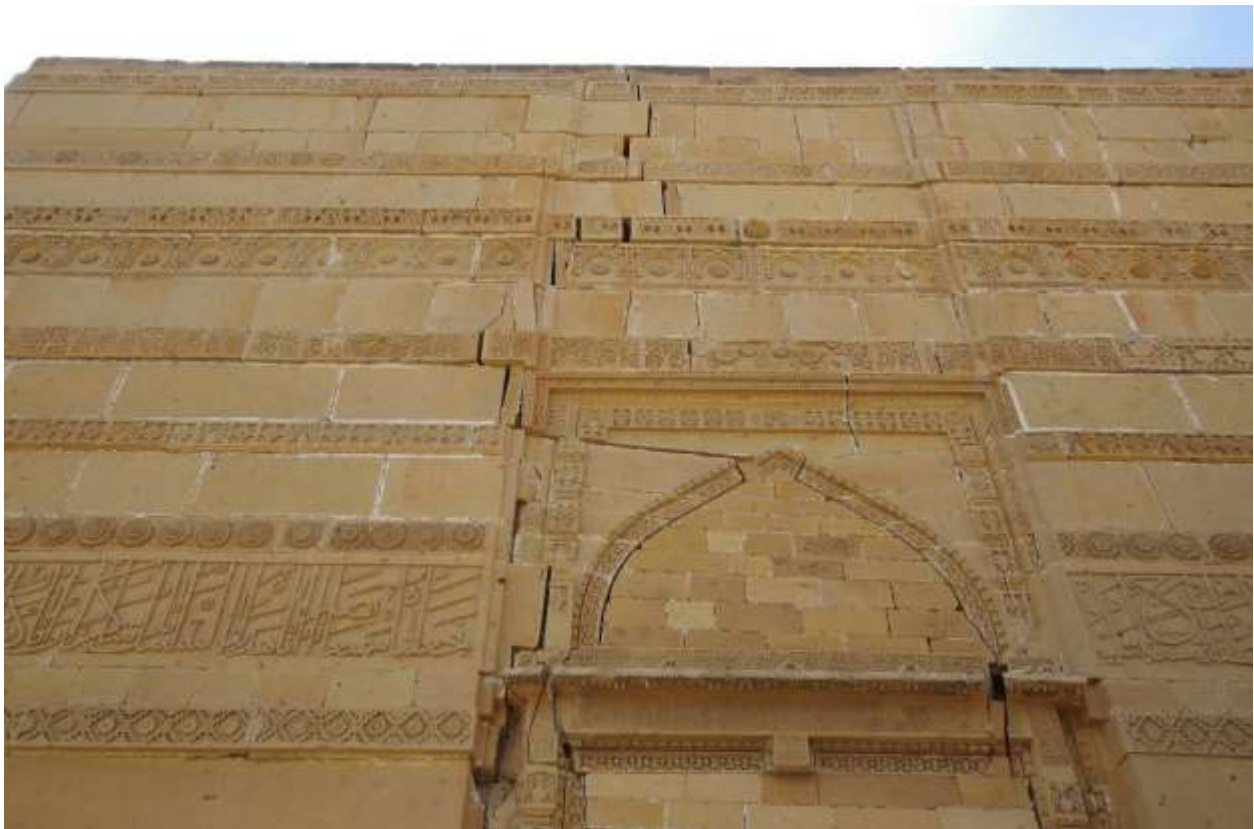
During the 1994 restoration of the monument, all apparent cracks were patched with matching stone pieces and surkhi lime mortar. Today, it can clearly be seen that these cracks have meanwhile opened up by approx. 18 mm at the northern wall (image 12). At the southern wall, no significant openings next to the conservation works of 1994 are apparent. At the maximum, slight openings of about 3-4mm might have formed since the 1994 intervention. Since the installation of the crack meters at various locations at the building by the end of 2017, no movement could be discerned. However, the accuracy of the installed crack meters is not high enough to discern small movements below 1mm. The crack openings on the north wall suggest an ongoing movement of approx. 1 mm per year on the northern side and about a third of that on the southern side of the monument.

Image 12: Upper part of north façade with opening gaps between the stone elements (some former infill patches caved outwards and are missing, the maximum opening since 1994 measures approx. 18mm.)

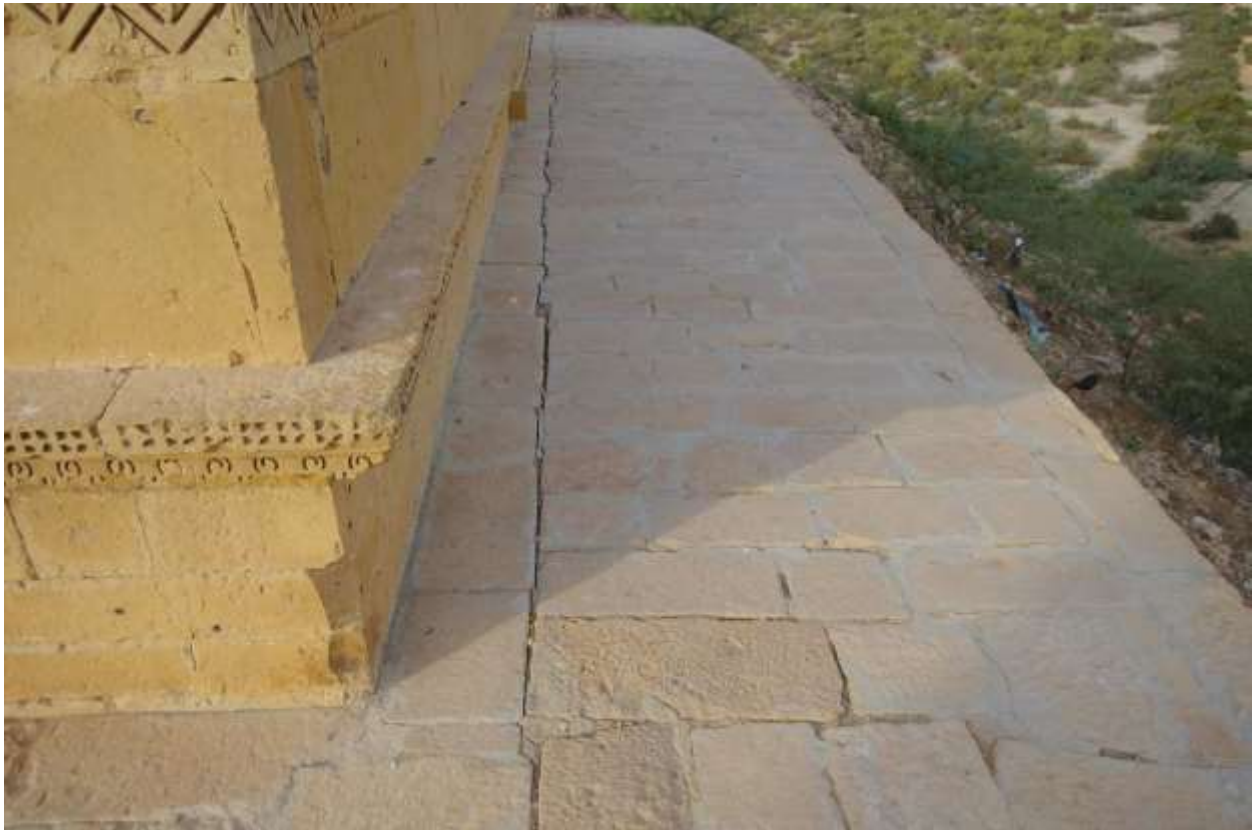
In 1994, a retaining wall was built just next to the eastern foundation wall. The L-shaped wall made of reinforced concrete and was embedded in brickwork. It now forms the embankment next to the slope. In the same campaign, the cracks in the masonry walls were also repaired and repointed with red coloured lime mortar (surkhi). As the newly built retaining wall is not tied into the soil and only runs parallel to the existing foundation wall, it did nothing to stop nor contain the movement. In fact, soon after the retaining wall was built, new cracks formed along the retaining wall and in the masonry, particularly on the northern side of the building. The observation that the horizontal movement at the northern side - which is also bit closer to the edge of the cliff - is more acute than at the southern side can be witnessed at the encasement of the retaining wall at the eastern face of the building. Here, a longitudinal crack in south-north direction has formed just above the embedded reinforced concrete wall. The crack opens up from approx. 2mm at the southern end to about 20mm at the northern end.

The ongoing erosion of the layer of loam at the cliff has an important effect of the stability of Jam Nizam al Din: under normal conditions, the weak layer of loam would be contained in every direction and not able to expand in any direction. However, as the ongoing erosion of the cliff has already substantially decreased the distance between the edge of the cliff and the foundations of the tomb. Consequently, the layer of loam is not equally constrained in all directions any more. Subjected to the heavy mass of the tomb, it will expand eastwards, as the decreasing distance to the cliff provides no restraint any more horizontal expansion in this direction. This effect is exacerbated if the moisture content of the layer rises. For this reason, it is quite harmful that the waterspout currently dewateres directly into the gap between the existing foundation wall and the retaining wall (image 13).

Image 13: Encasement of the added retaining wall (1994), showing a horizontal gap with increasing width from south to north. Note that the waterspout that drains the central space dewateres directly into the crack between the foundation wall and the newly built retaining wall, which is encased in the plinth (built in 1994). The water is trapped in the gap in between and is funnelled directly to the moisture-sensitive clayish layer below the foundation walls.

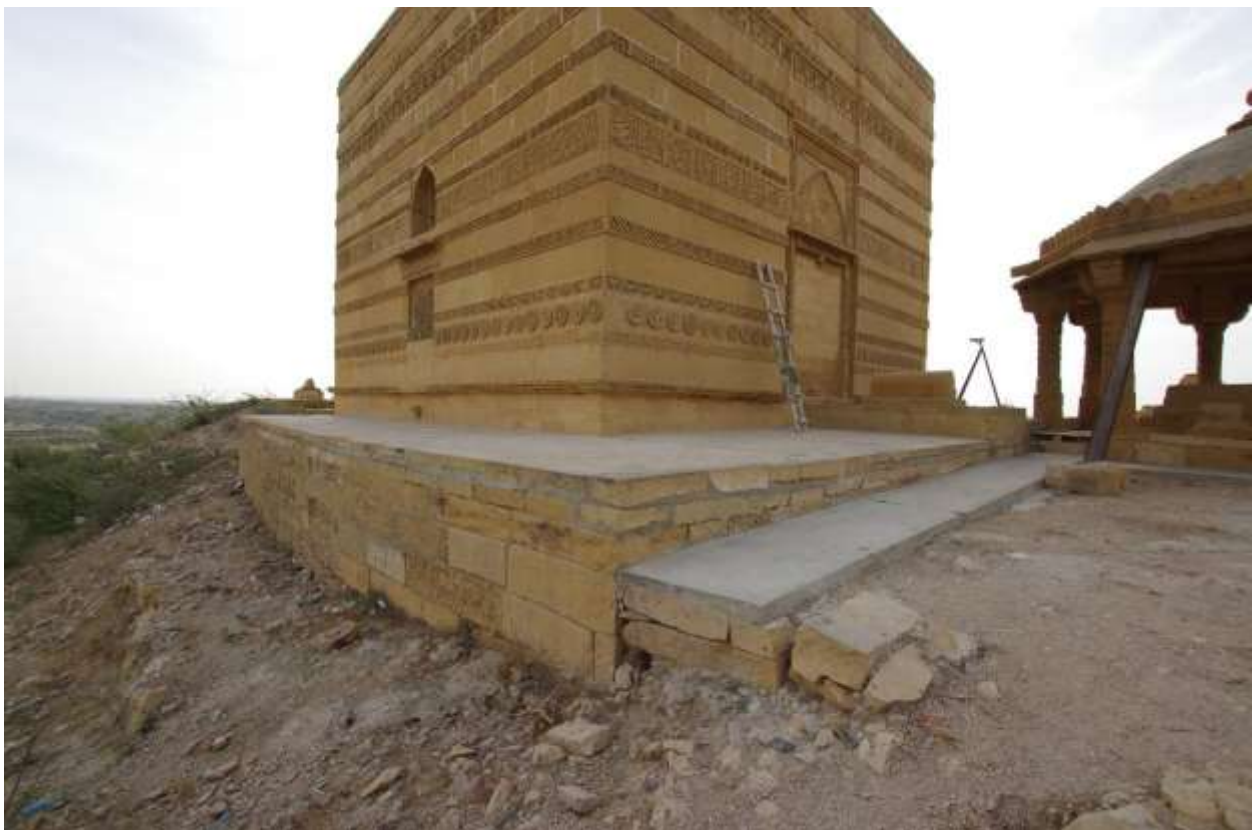
Image 14: North-east corner of Jam Nizam al Din with the encased retaining wall (built in 1994) and – below, right side, the newly added apron made of cement mortar for rainwater protection.

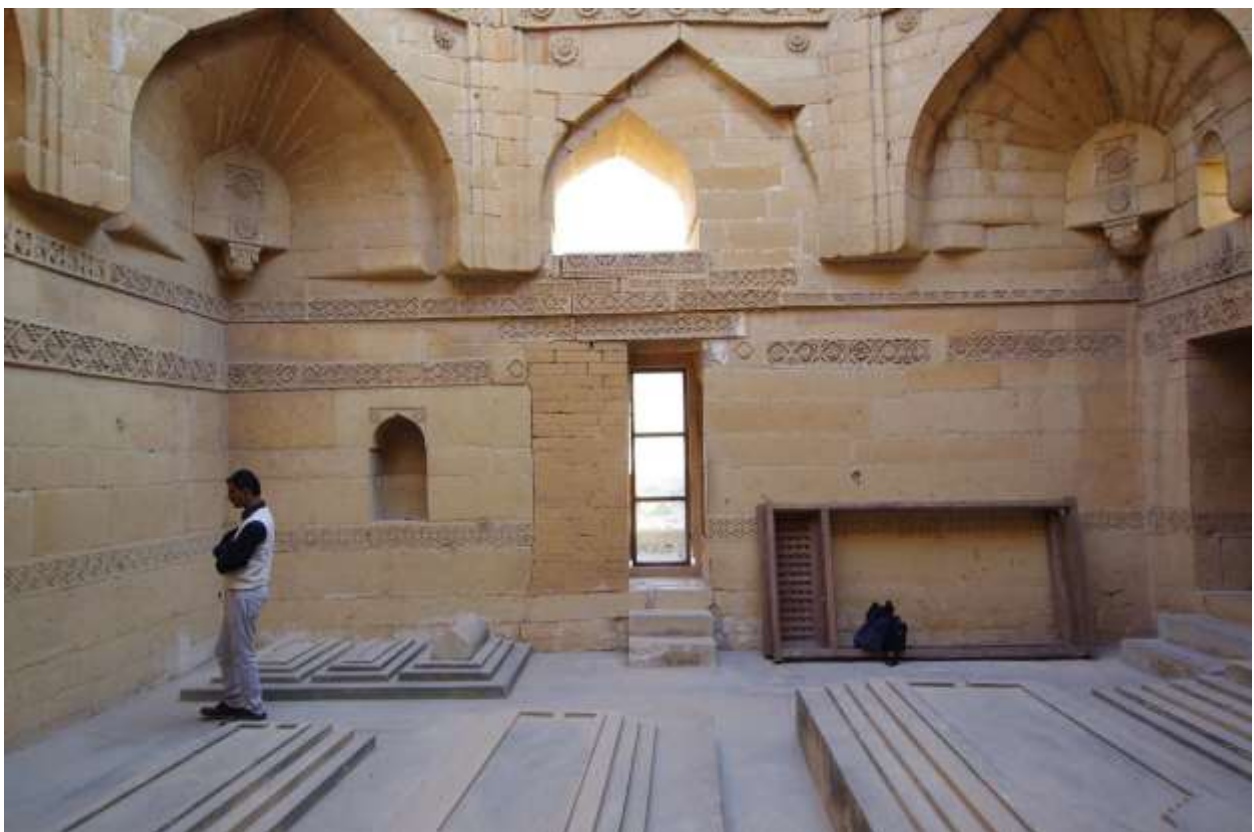
Image 16: Central space of the tomb, looking south (the infill of the south gateway was most likely added in 1956).

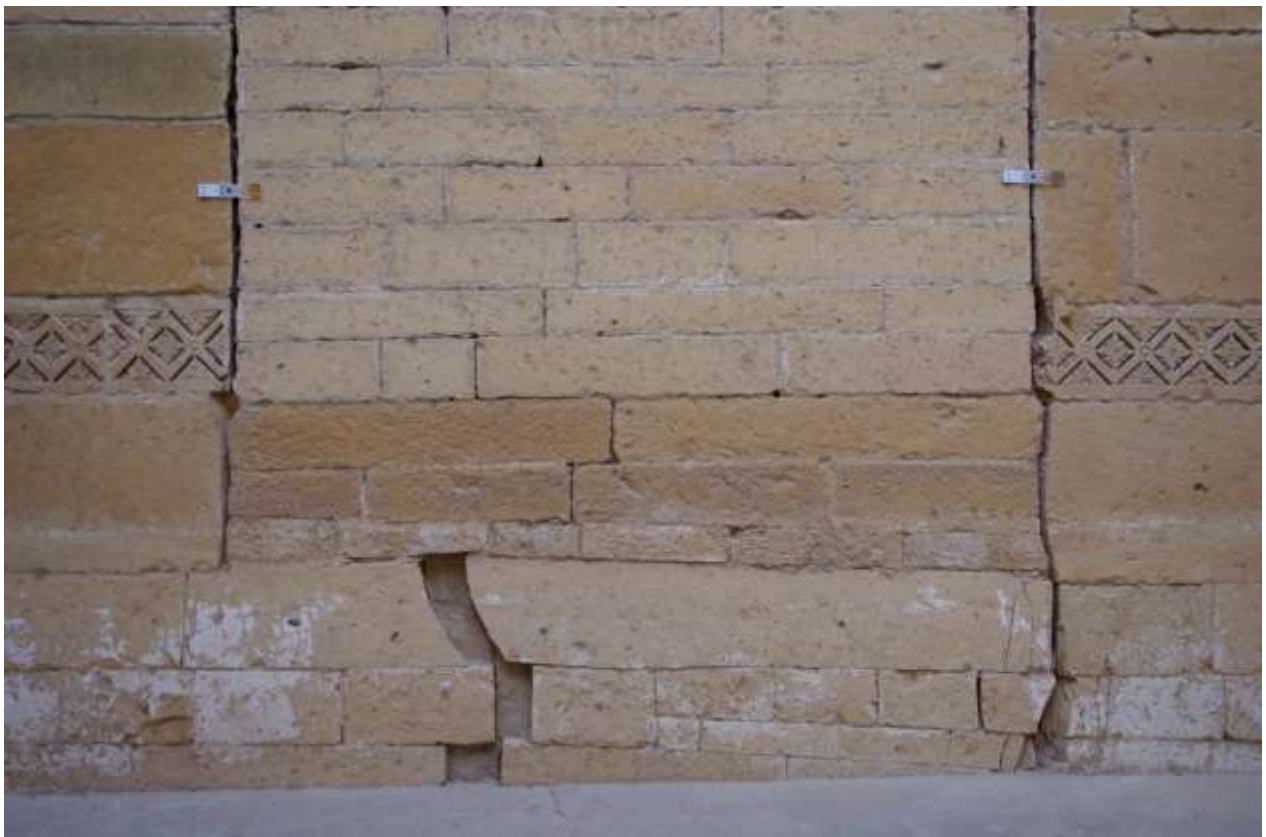
In effect, this means that the foundations (i.e. their eastern part) are not only subjected to vertical settlement but also to horizontal movement. This can be seen very clearly at image 18.

Image 18: Sealed northern doorway with installed crack-meters. The lower (previously sealed!) crack through the lowest three courses shows very clearly that the foundations of the monument are not only subject to vertical settlement but also to horizontal sliding.

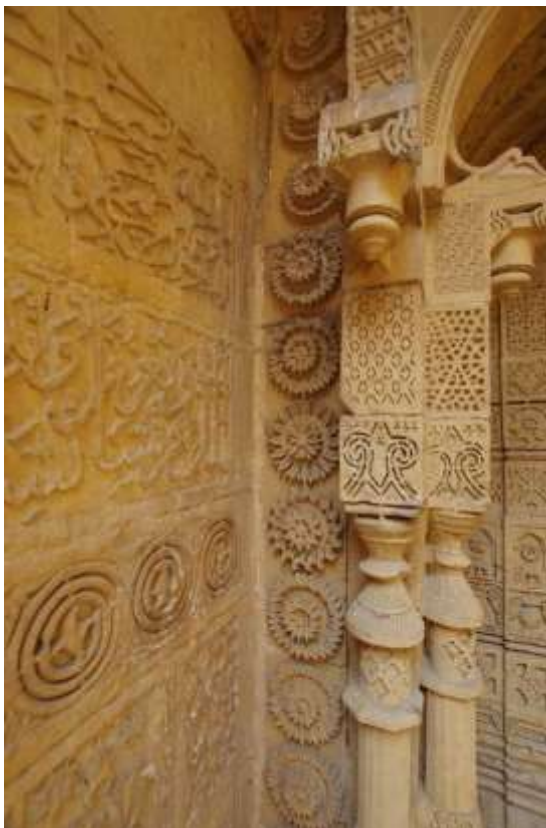
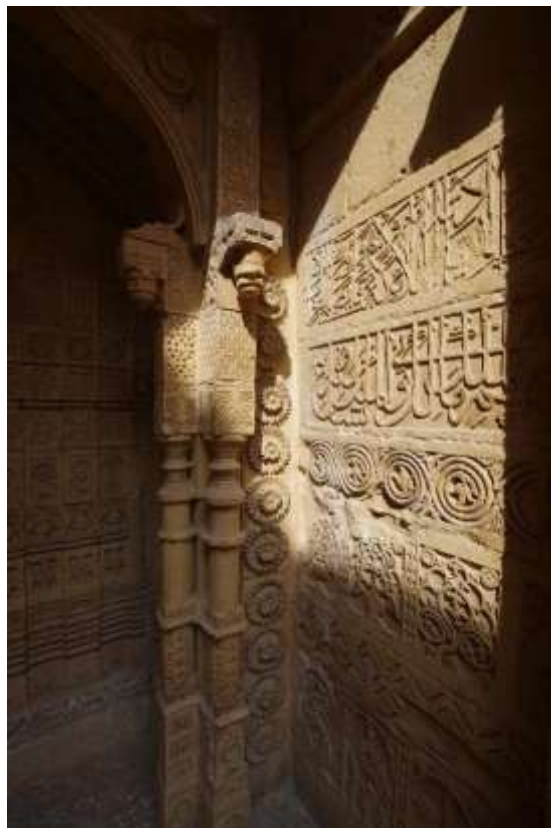
Currently, there seems to be no ongoing deformation at the Darshan Jharoka. This observation is substantiated by the fact that the repointed areas in the niche of the mihrab (carried out 1994) are still intact and show no signs of movement.

Image 20 a/b: Repointed former cracks inside of the mihrab (carried out in 1994)

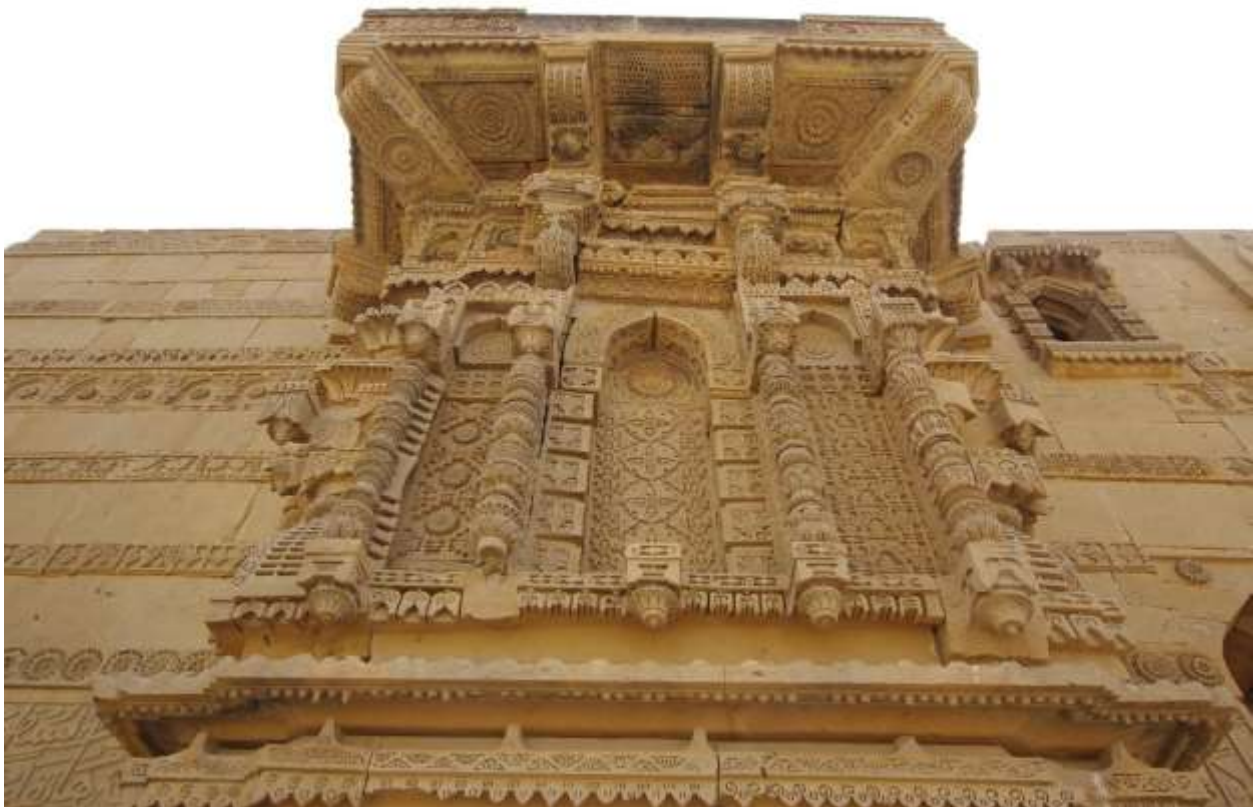
The prominent balcony structure at the Western face of the monument – the Darshan Jharoka – is the most prominent feature of the tomb of Jam Nizam al Din. The quality of the stone carving is of exquisite beauty and finesse. The central risalit of Darshan Jharoka shows partial detachment from the west wall of the tomb. Vertical gaps have opened up between the balcony structure and the main building due to insufficient keying of stone elements between the two parts.

Image 24: Central risalit, looking upwards, with severe cracks below the protruding balcony structure and elements bulging outwards left of the symmetry axis.

It is recommended to repair and strengthen the upper part of the balcony during by means of an anastylosis of the upper part of the drystone masonry. For this purpose, the cracked and dislodged stone down to approx. 1.8m below the balcony structure should be carefully disassembled. The cracked or damaged stone elements should be repaired in a stone conservation laboratory (to be set up inside of the entrance office facilities). The anastylosis and stone conservation works must be carried out by stone conservation experts with proven experience and expertise in the conservation of comparable monuments. In order to improve the keying between the central pilaster and the main structure and to enhance the seismic resistance of the upper part of the balcony structure, the (concealed and reversible) inclusion of glass fibre reinforcement should be investigated.

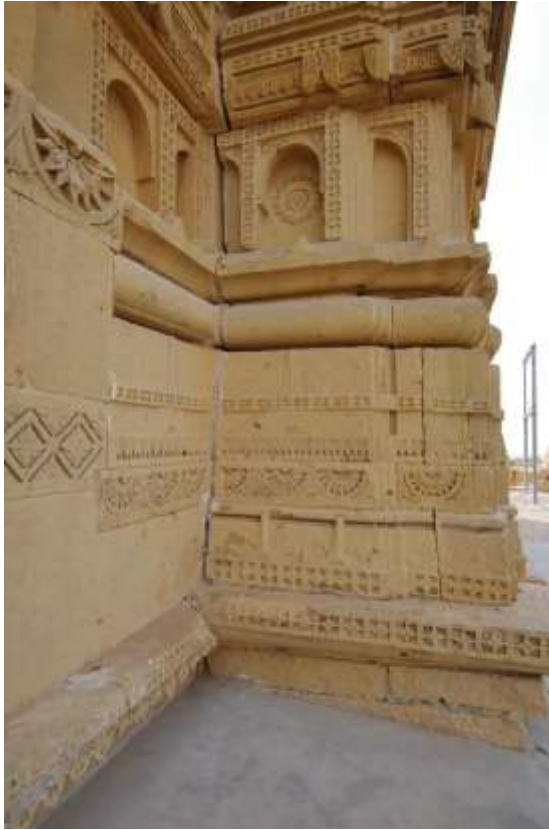
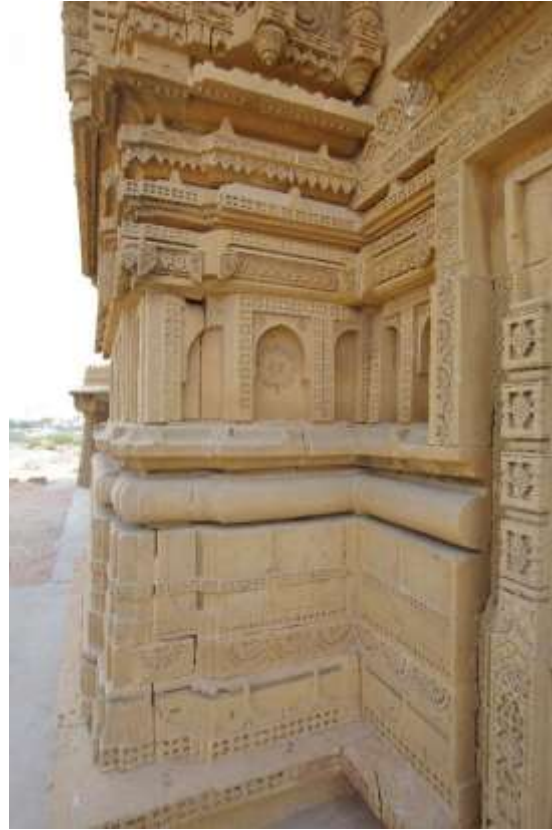
Images 25 a/b: Lower part of central risalit from north / south – with a continuous vertical gap on the north side.

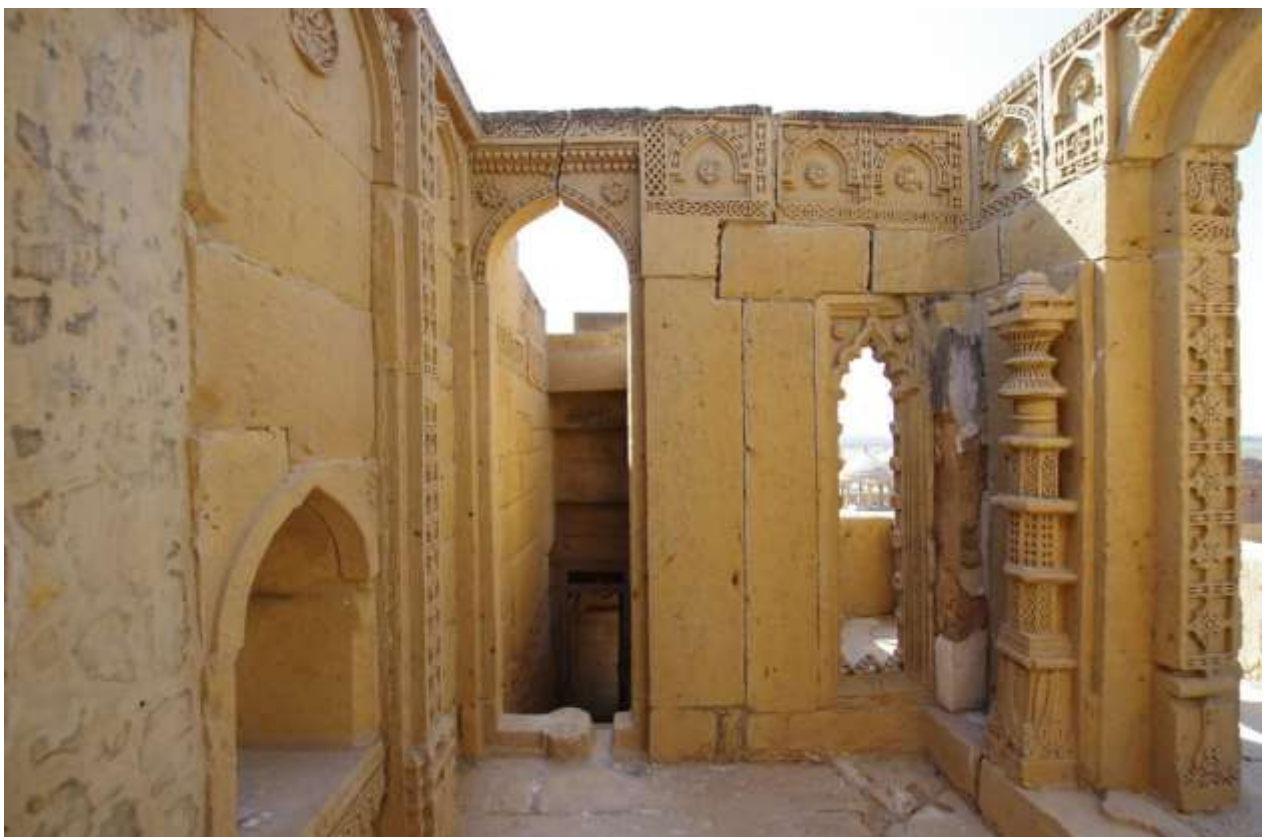
Image 30: Vestibule of the Darshan Jharoka, looking south, with the broken lintel above the doorway.

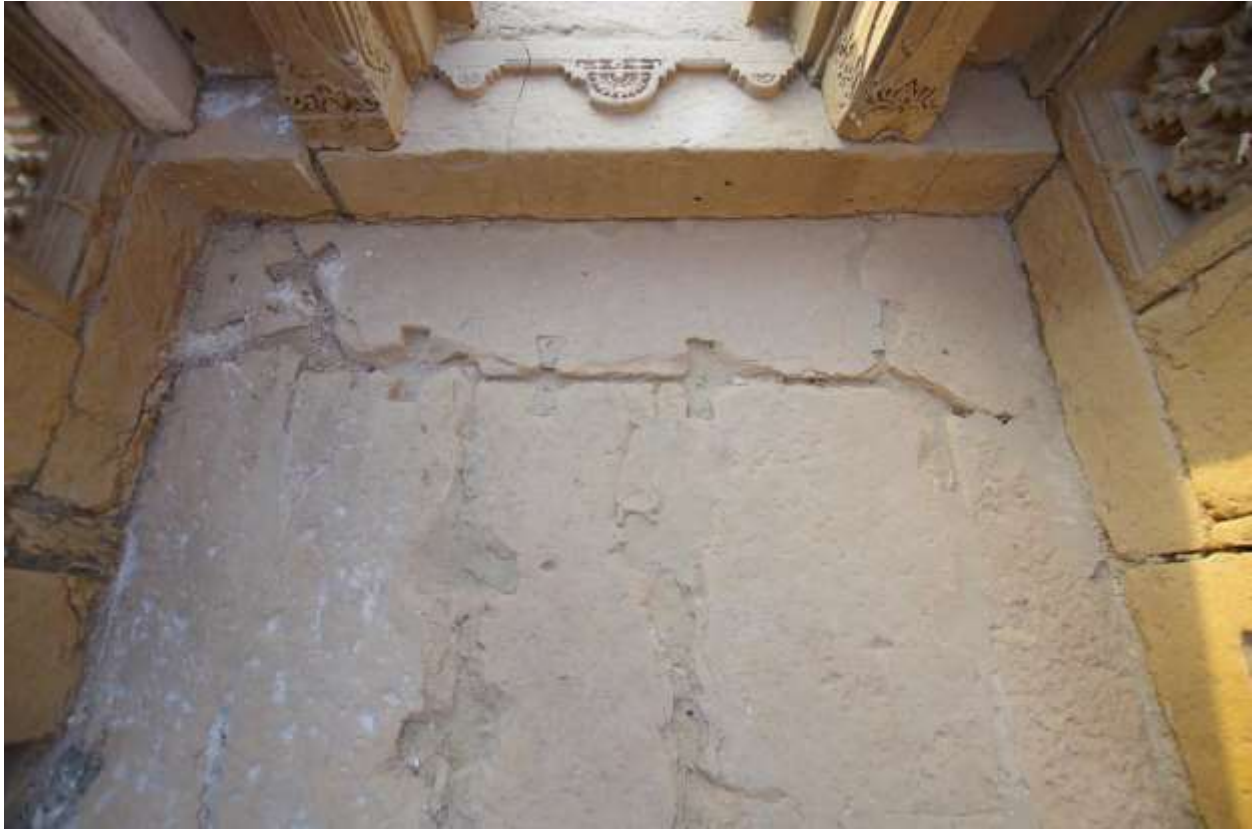
Image 31: Vestibule of the Darshan Jharoka, stone planks with missing iron clamps.

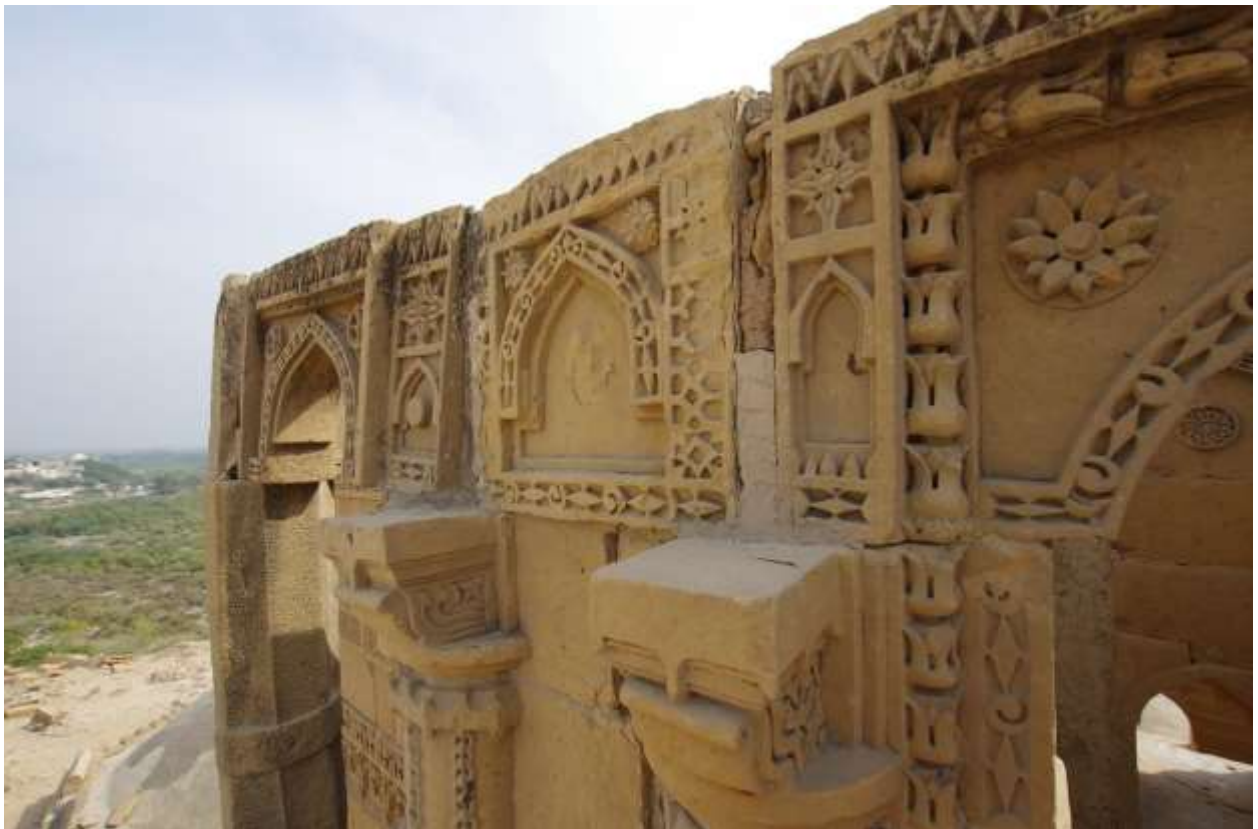
The earthquake damages at the Darshan Jharoka and the ensuing heavy-handed repair works have led to a structurally unsound and improper condition of much of the upper part of the balcony area. Gaps and dislodgements in the stone masonry have been patched or repointed - often in a very unsightly manner. The majority of the historic iron clamps that were once joining the stone slabs are missing. Original parts like door jambs, pilasters and other elements are missing. Most notably, the original column on the north-western corner of the balcony has been replaced by a mismatching column of unknown origin. As this element is too high, it also causes disturbance at the lintels above, which are not aligned horizontally as a result.

Image 32: Upper entablature of balcony structure, looking north. The disruption and perturbation of the structural elements is clearly visible, with wide (partly repointed) gaps, dislodgements and misalignments and lost original elements (e.g. post on the left hand side).

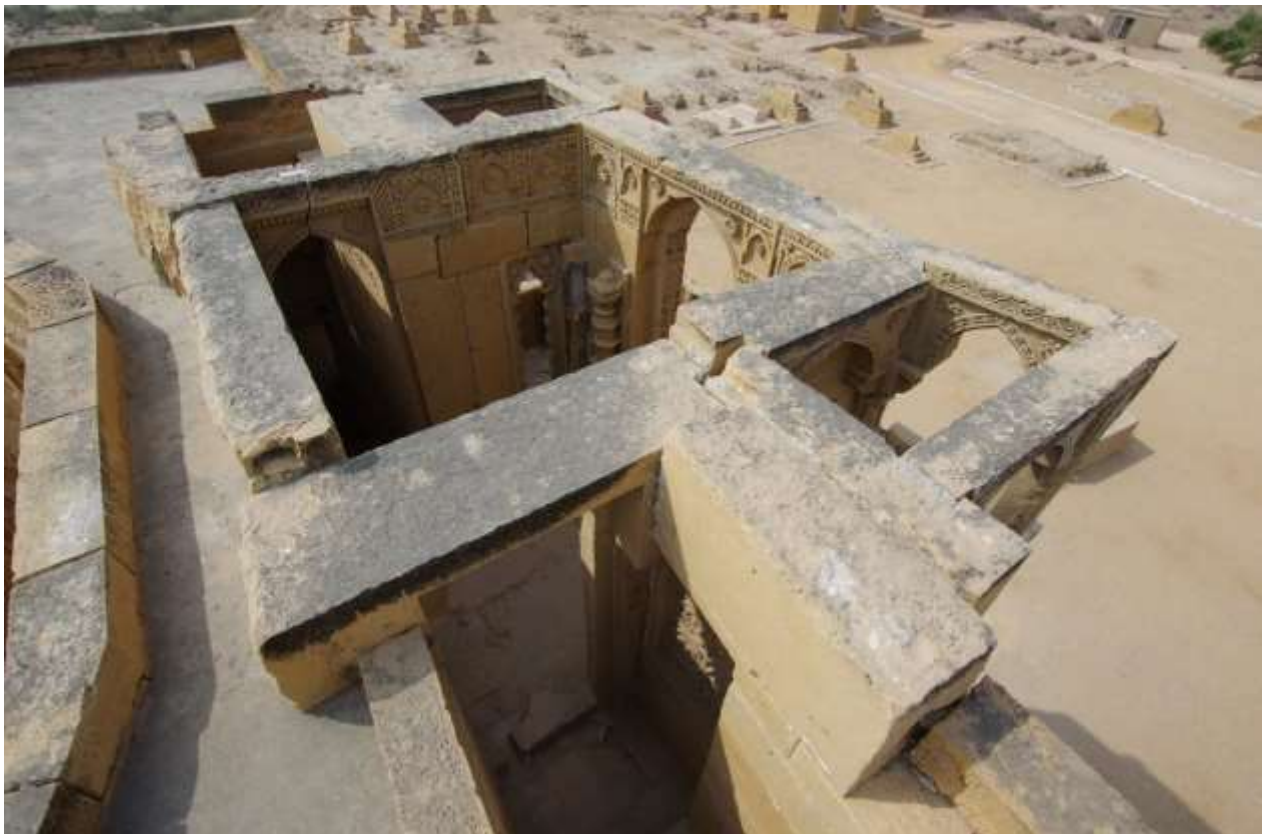
Image 34: Top view of the balcony structure, showing the severe dislodgements and misalignments.

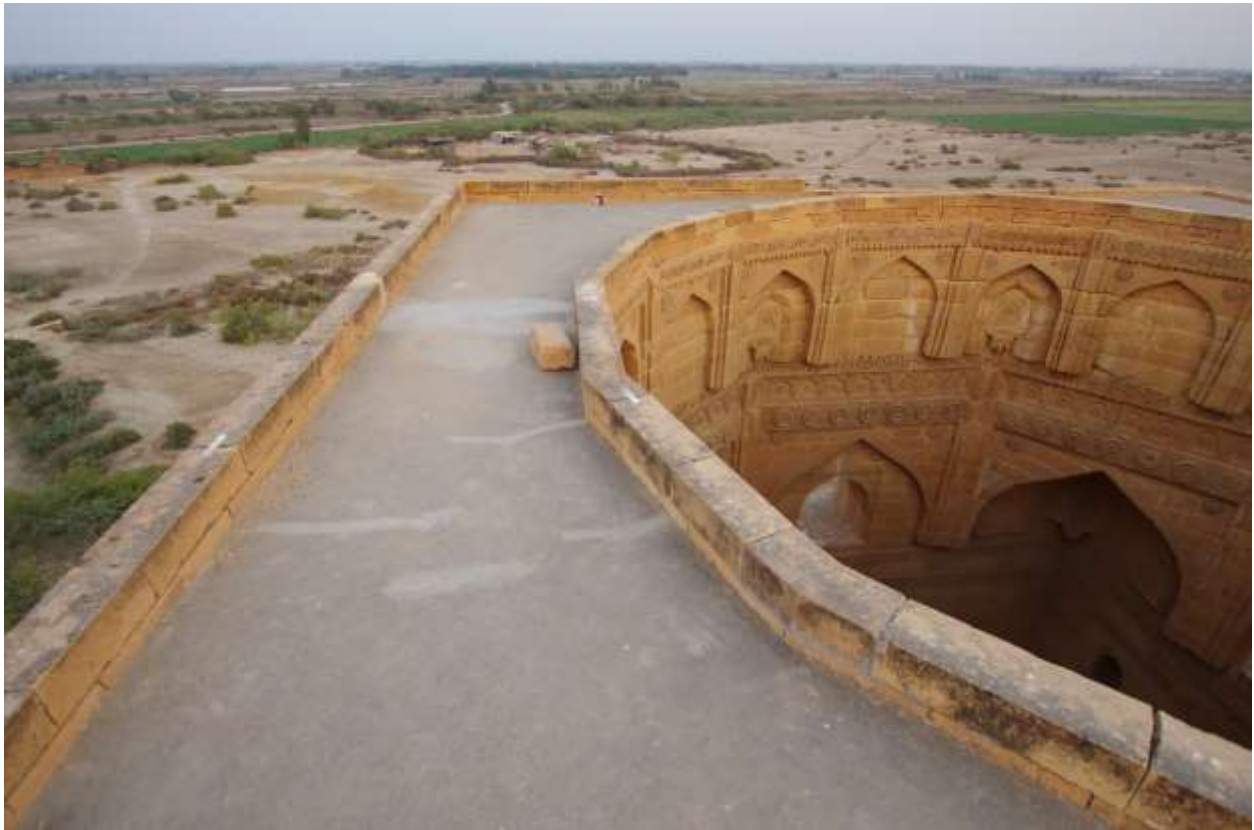
Image 35: Top level with cement flooring and the two added courses of stones (1956).

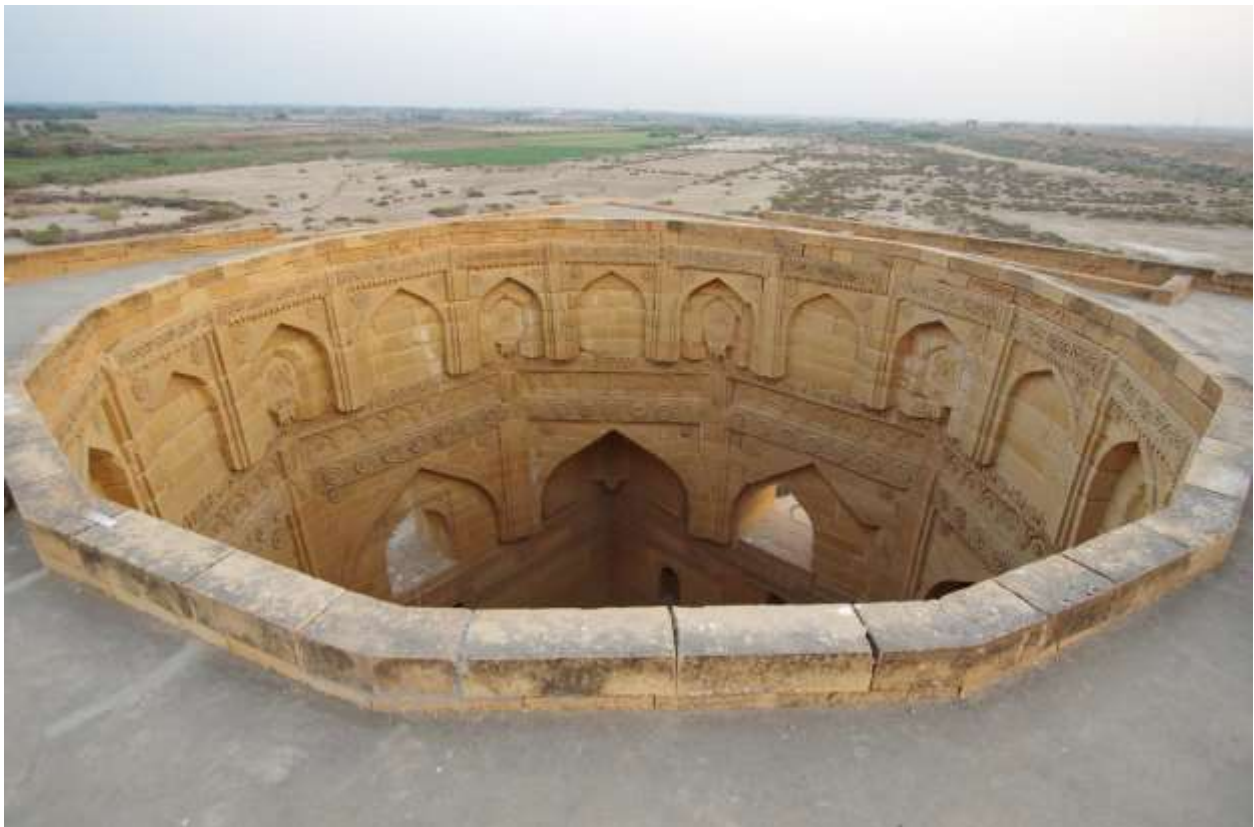
Image 36: Top level with cement flooring and the two added courses of stones (probably carried out in 1956 by the department of public works).

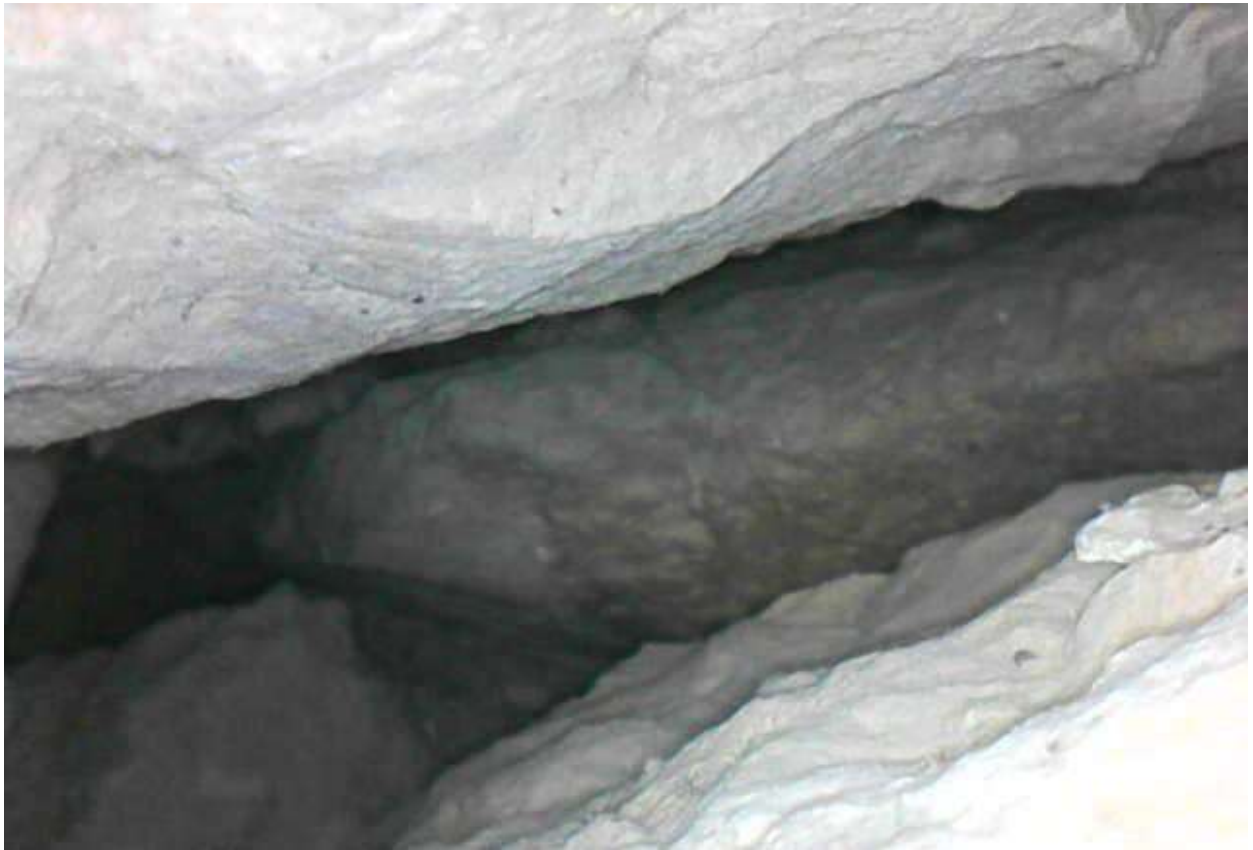
construction method was widely used for the vast majority of coeval monuments in the area. This assumption was further corroborated by an endoscopic survey (image 37).

Image 37: Endoscopic view of a cavity next to the gateway at the northern wall, showing the inner layer of rubble stones.

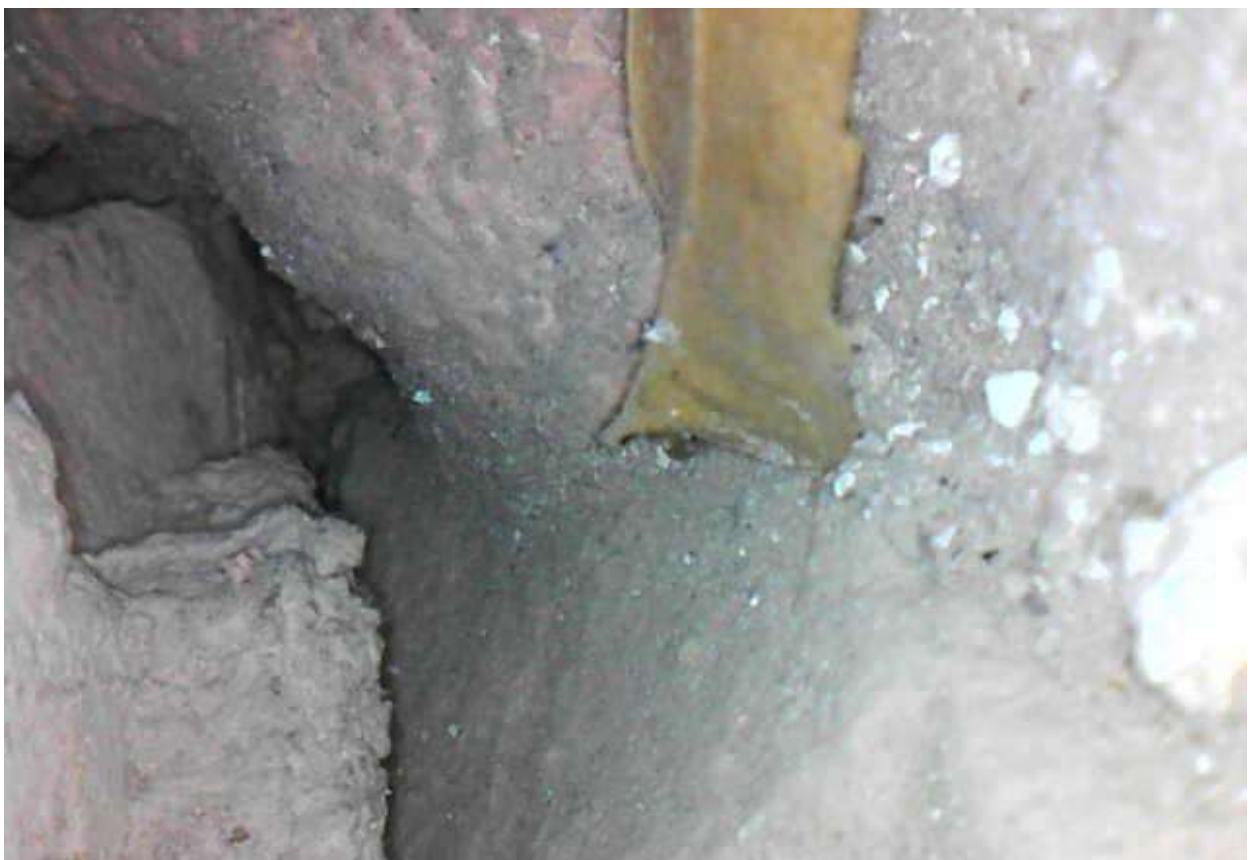
Image 38: Endoscopic view of crack between the detached central pilaster and the main structure. It shows a patched crack within the mihrab niche (taken from the opposite site).
