RESTORATION AND CONSERVATION OF

KOTDIJI REMAINS

DISTRICT KHAIRPUR MIR'S.

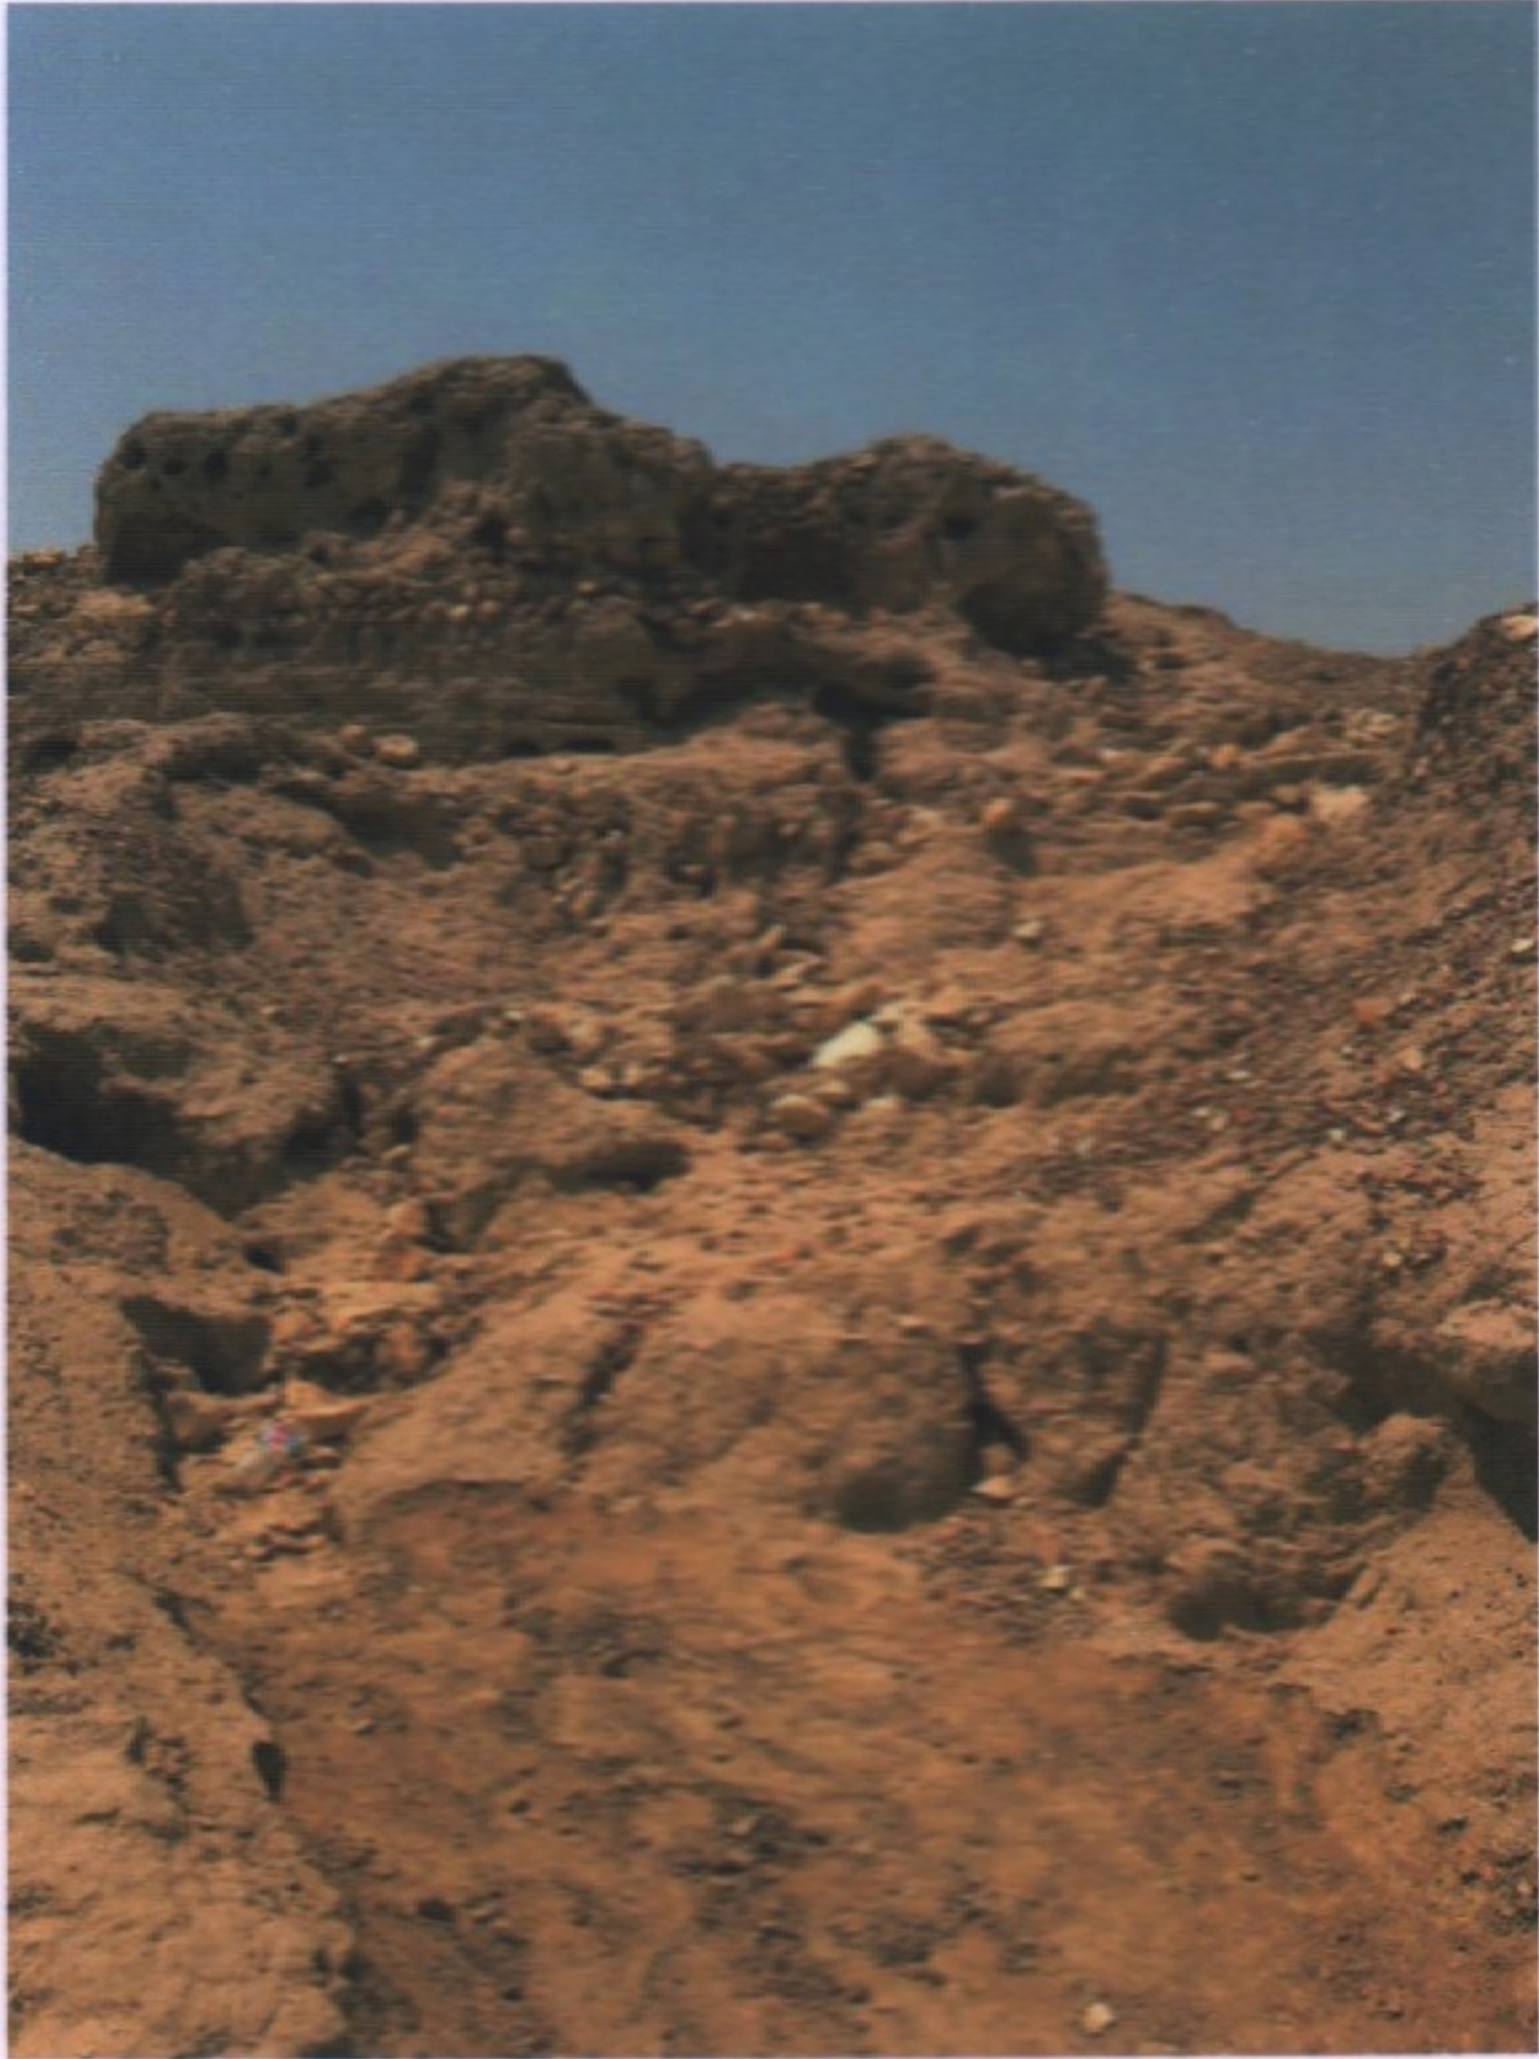
Excavation work at Koldiji remains.

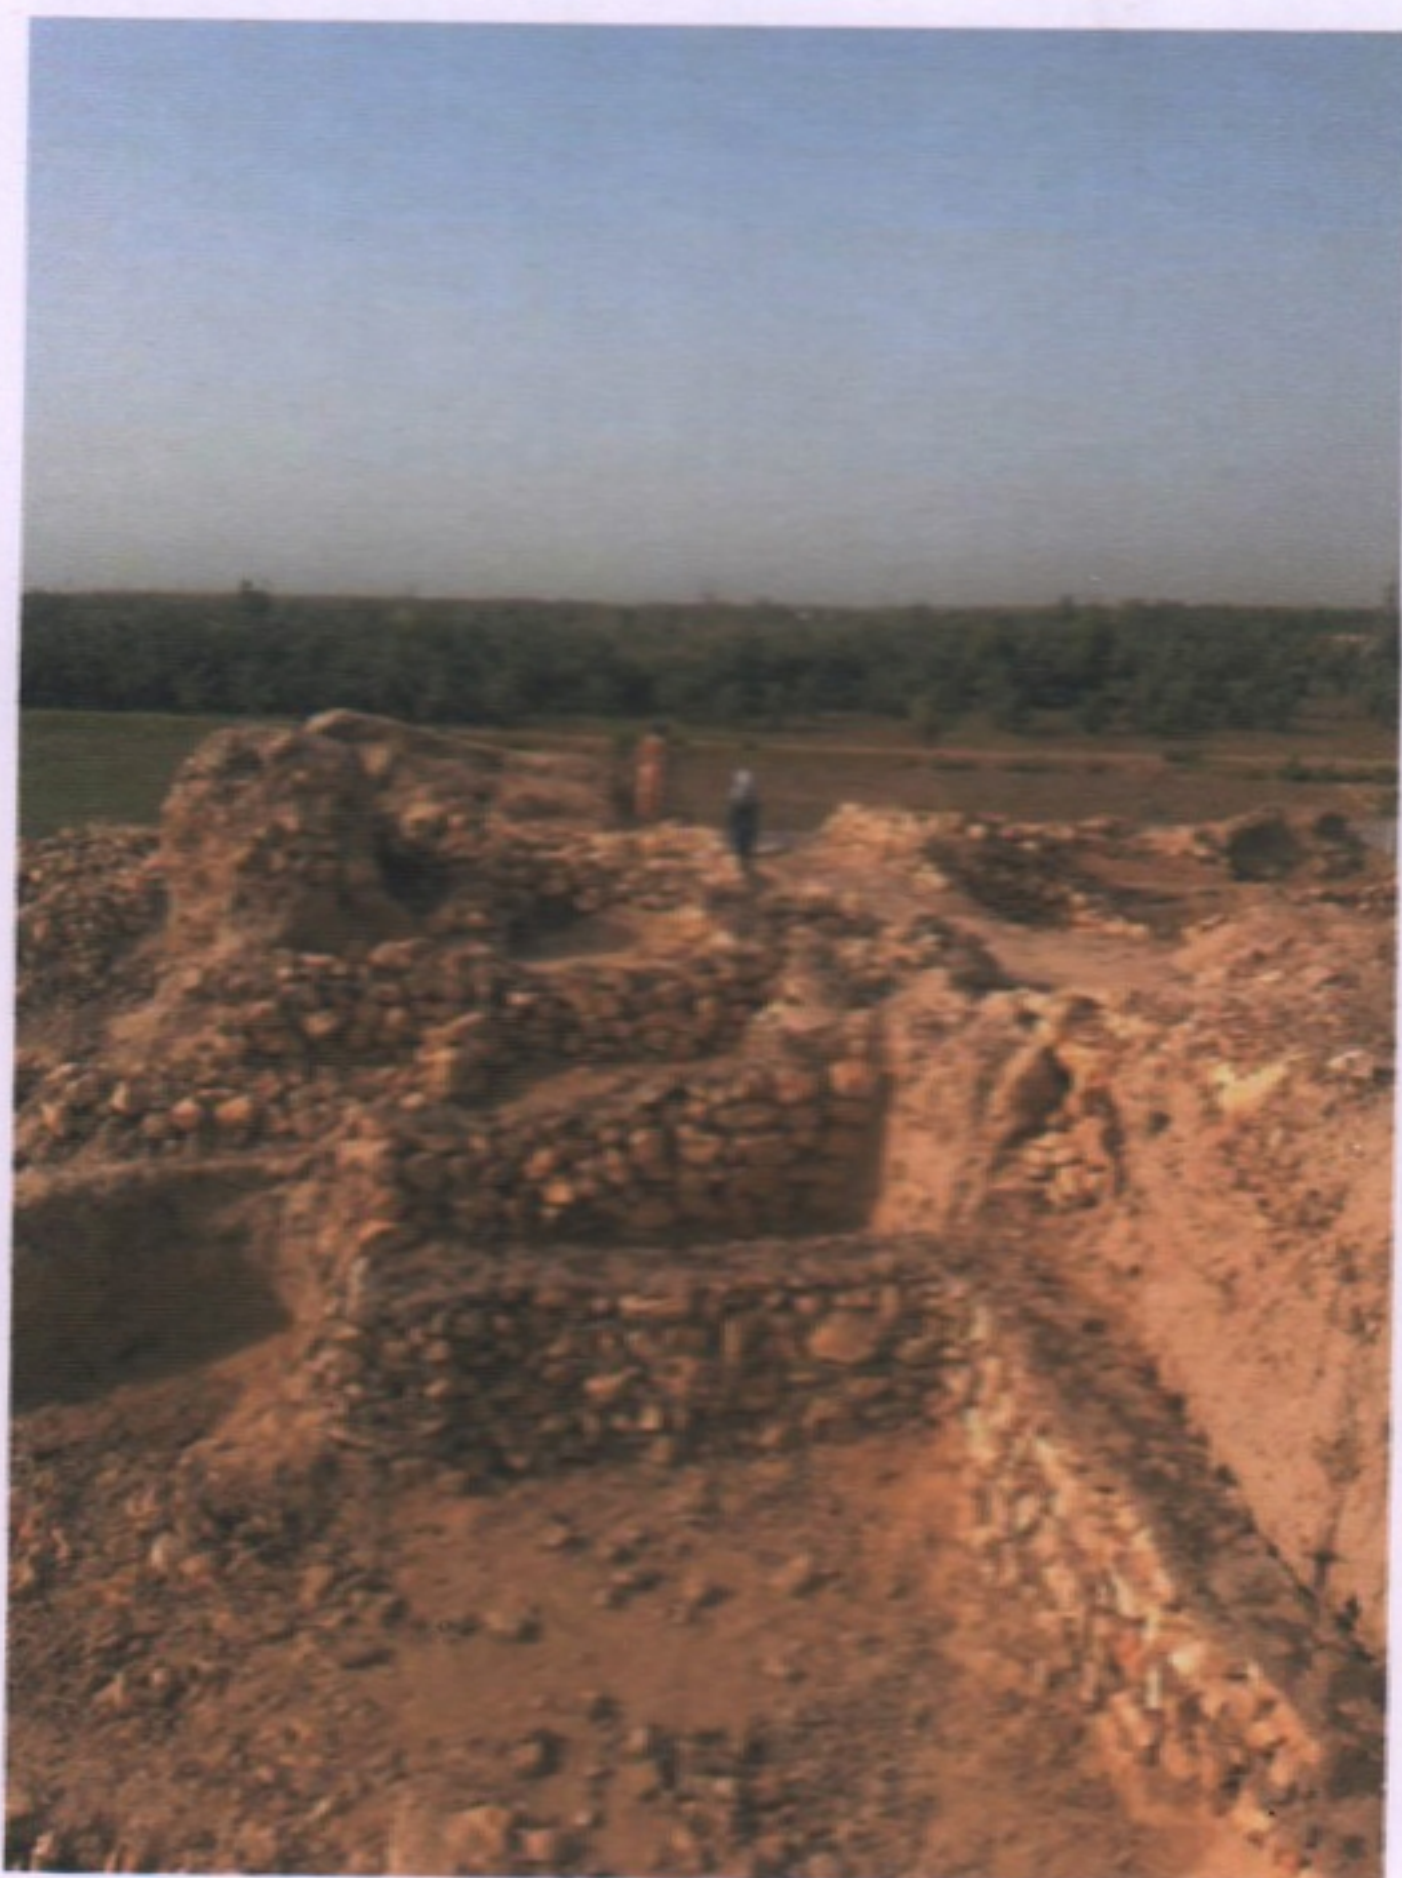
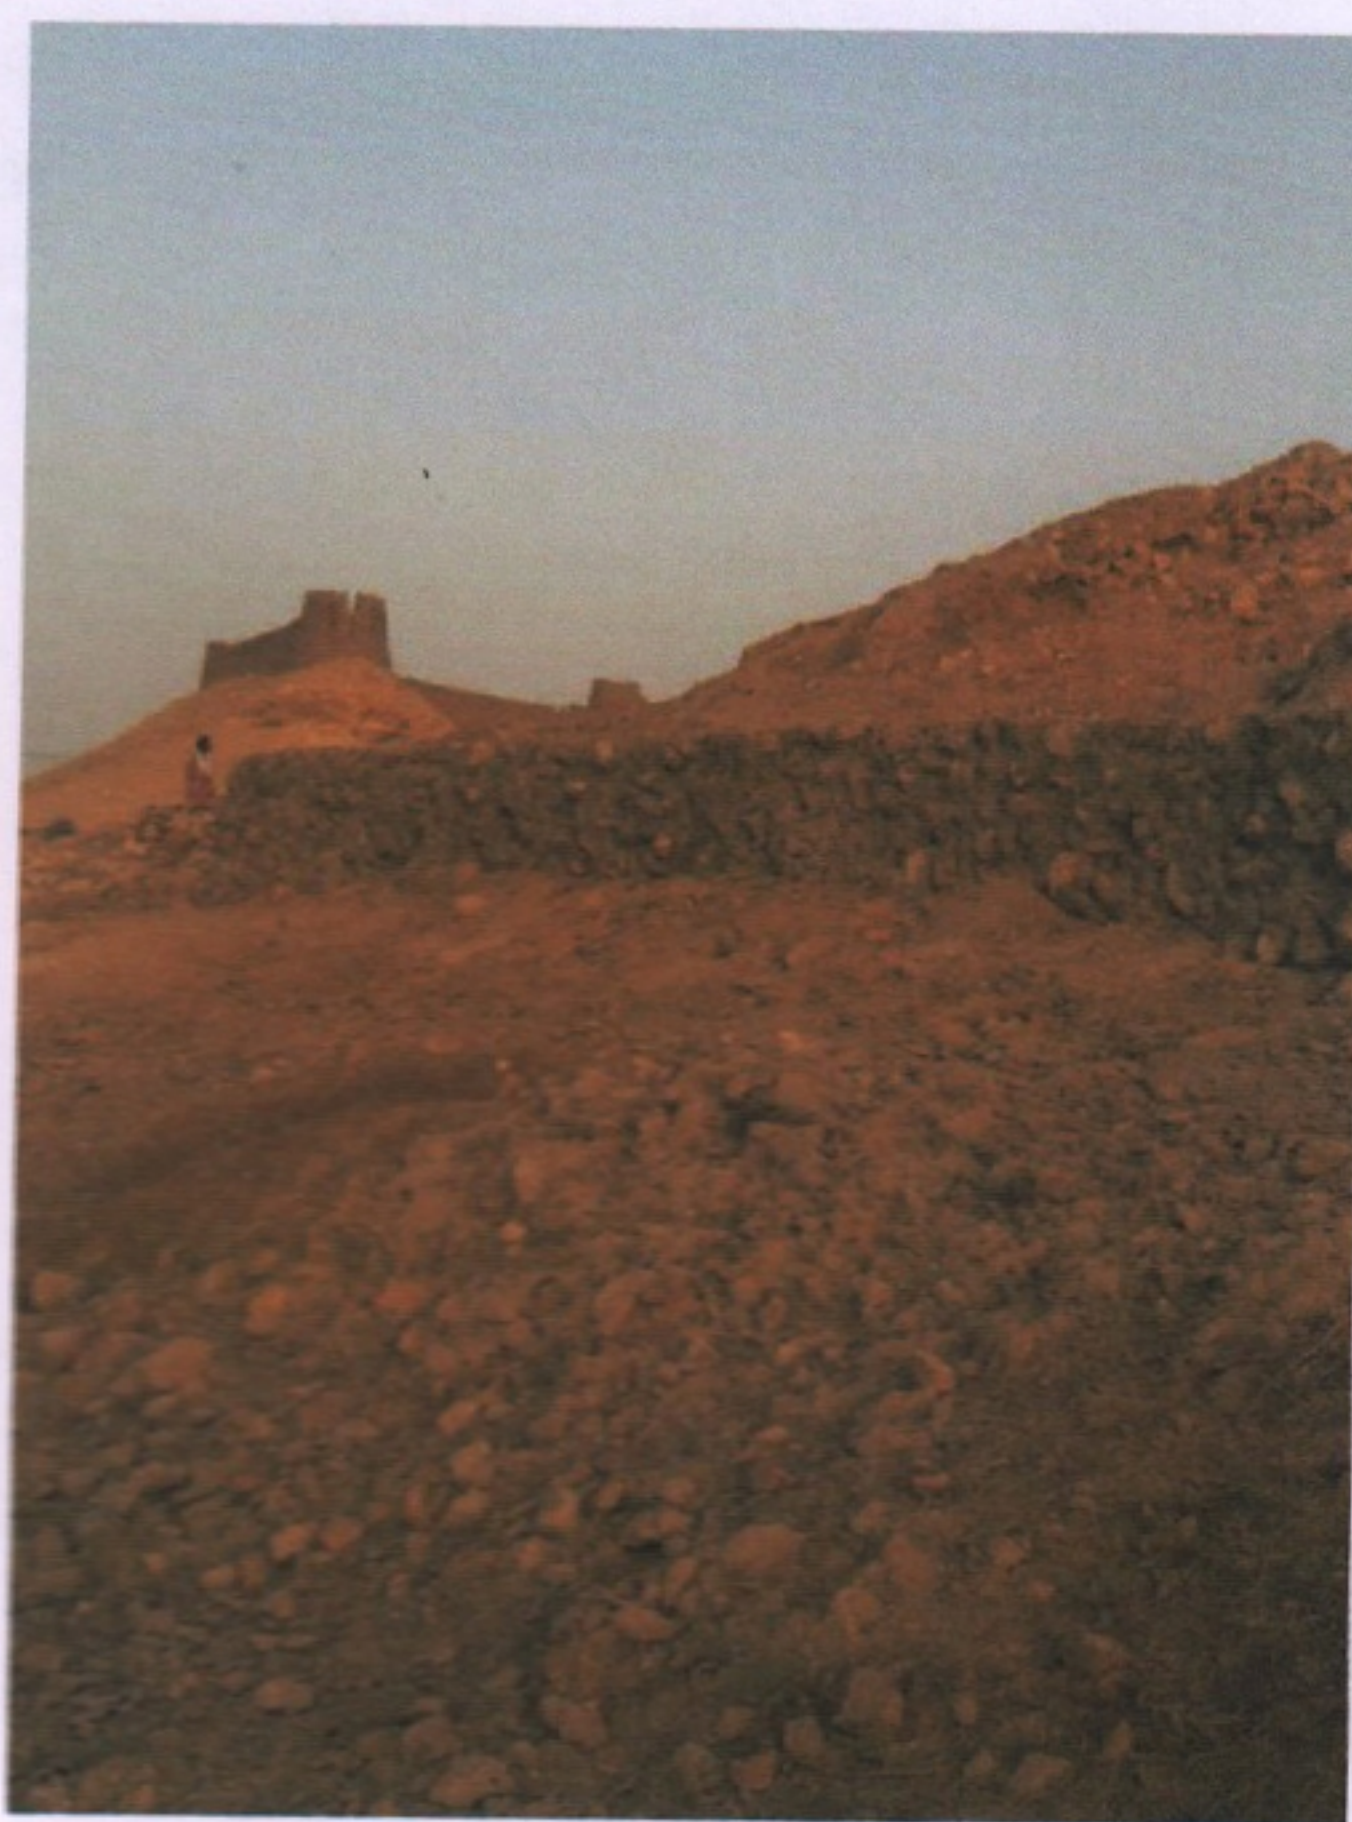
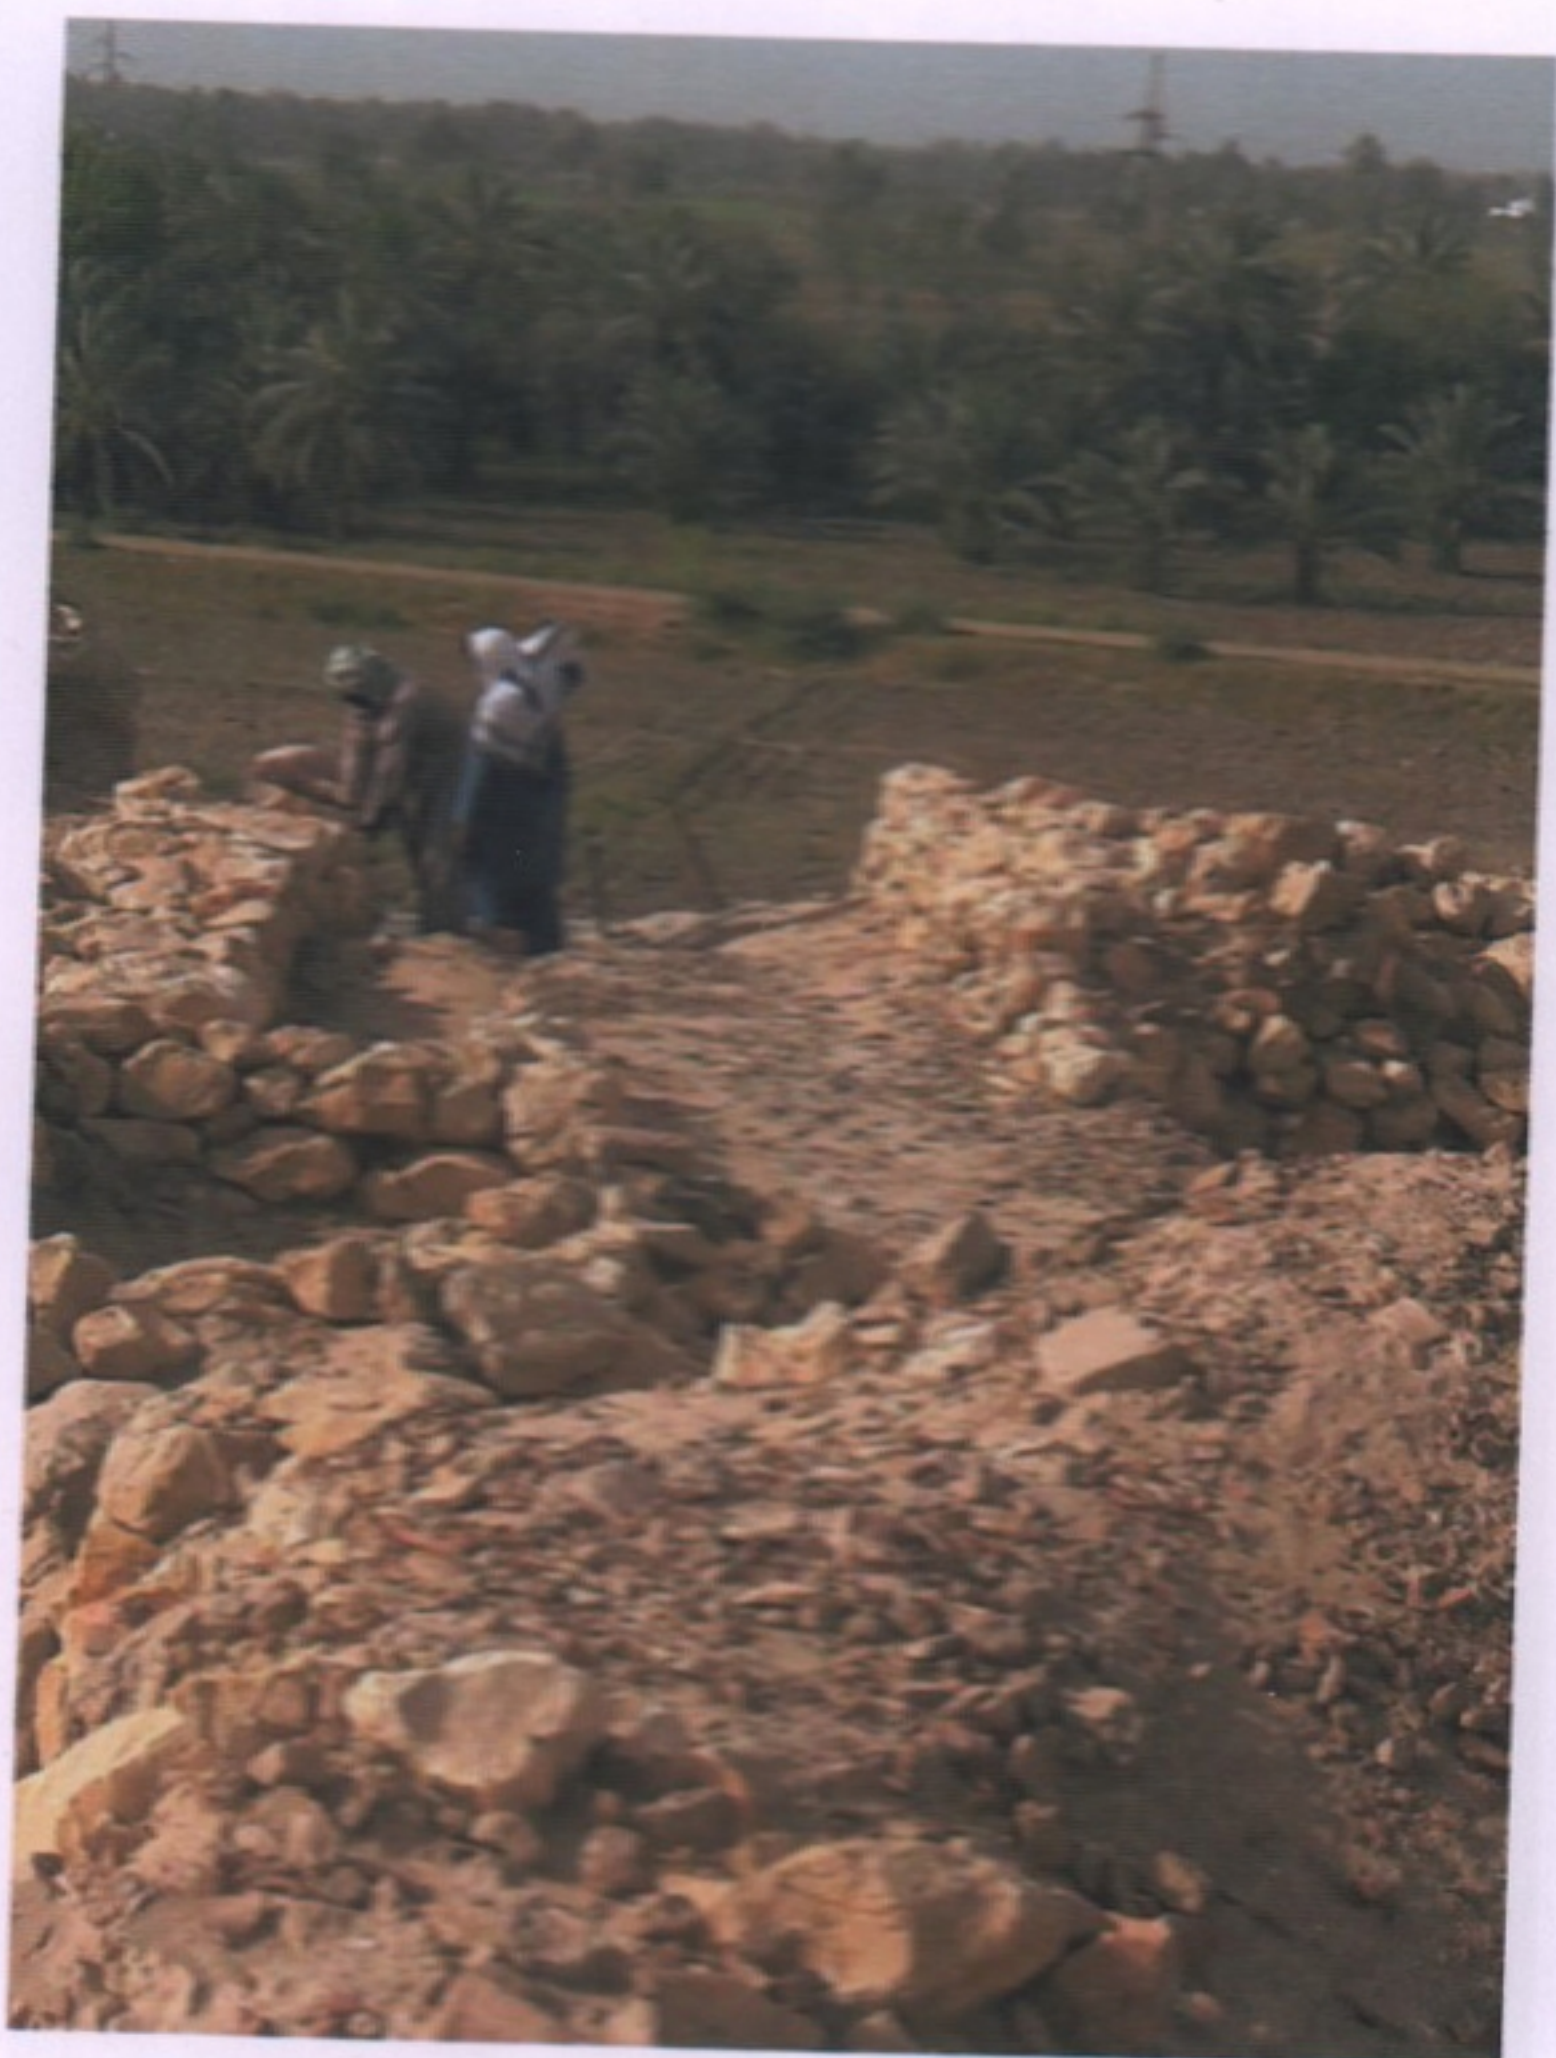
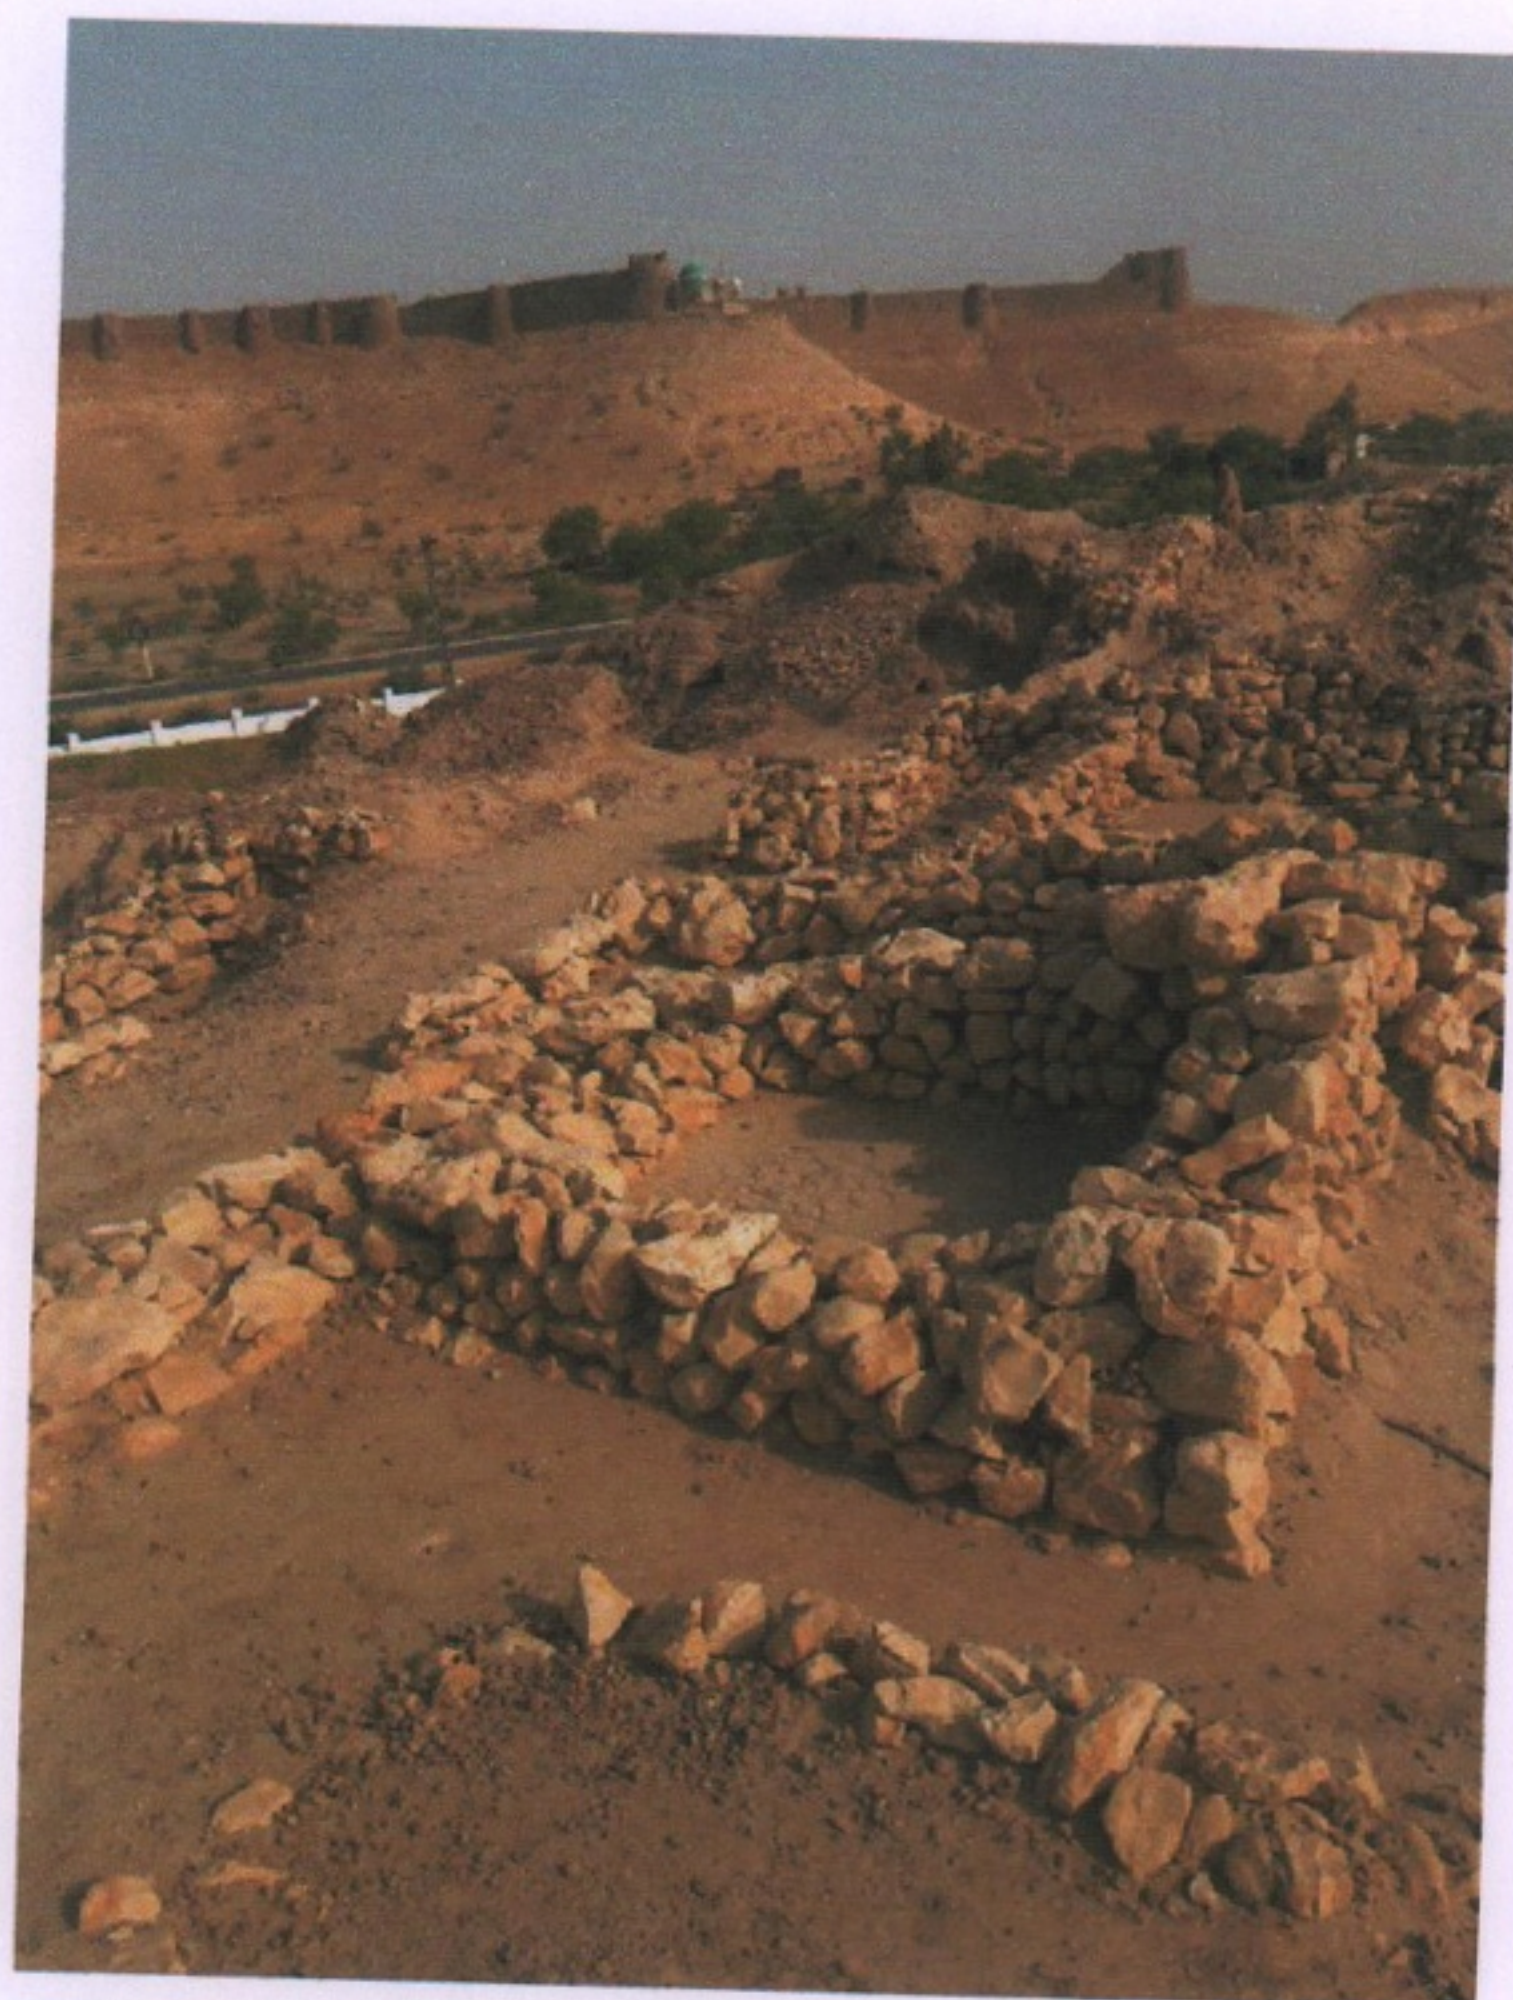
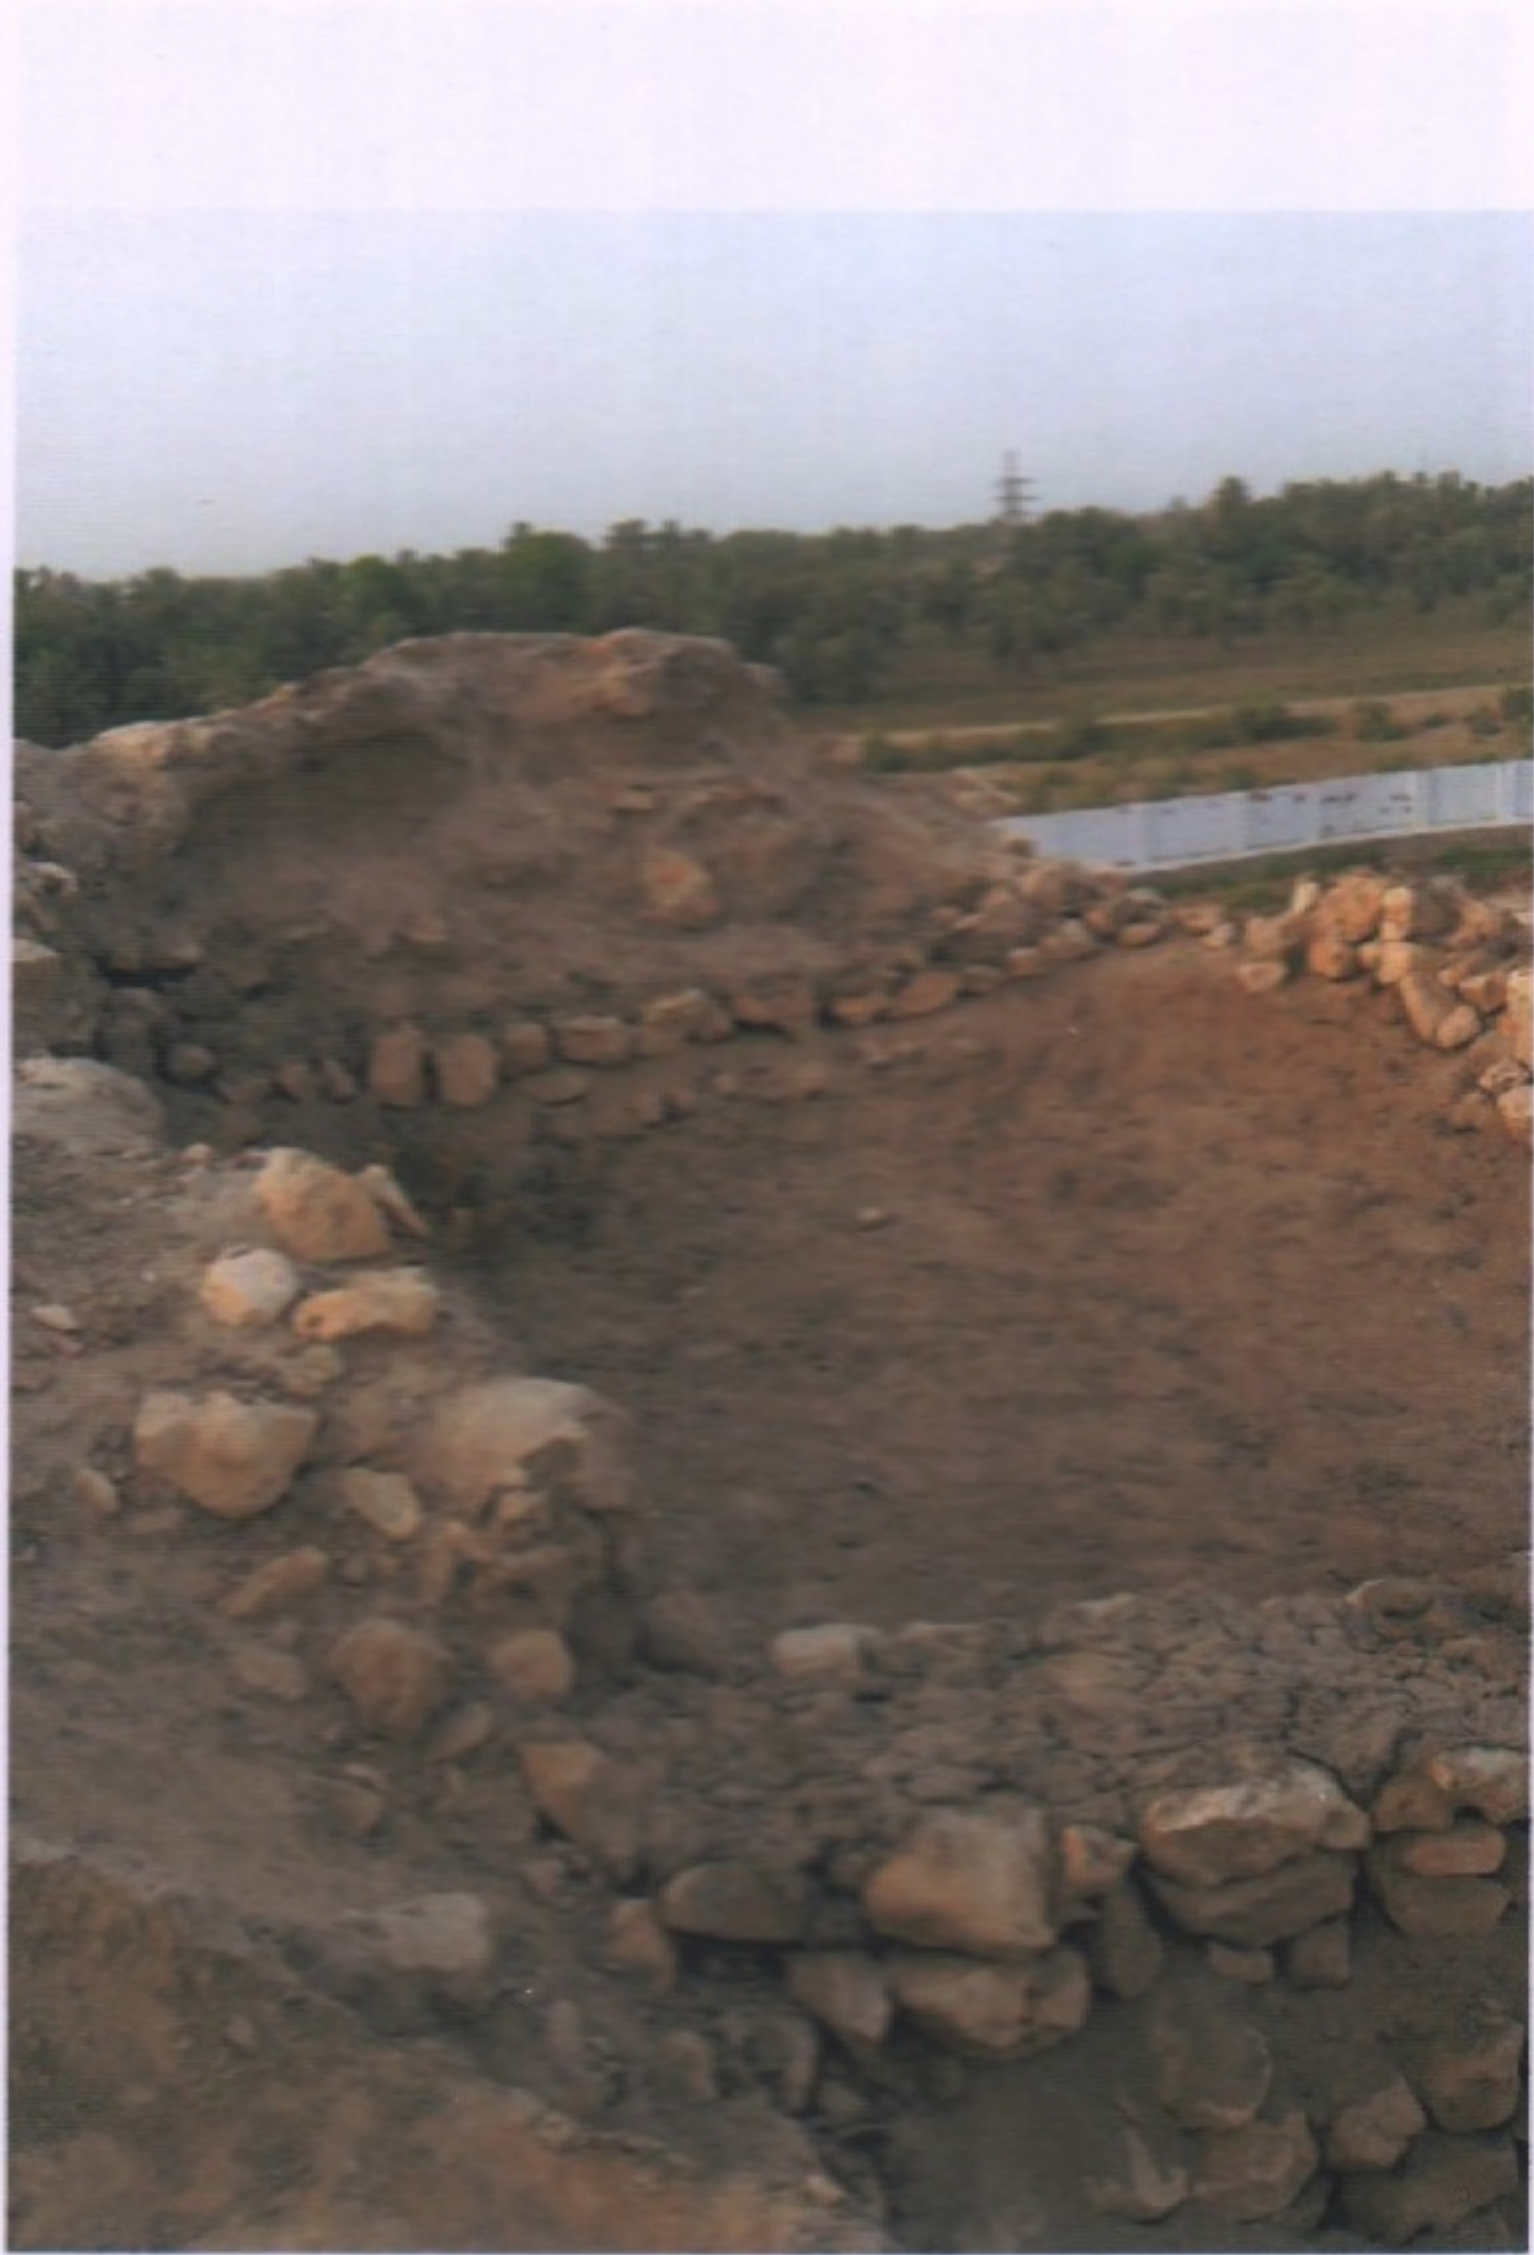
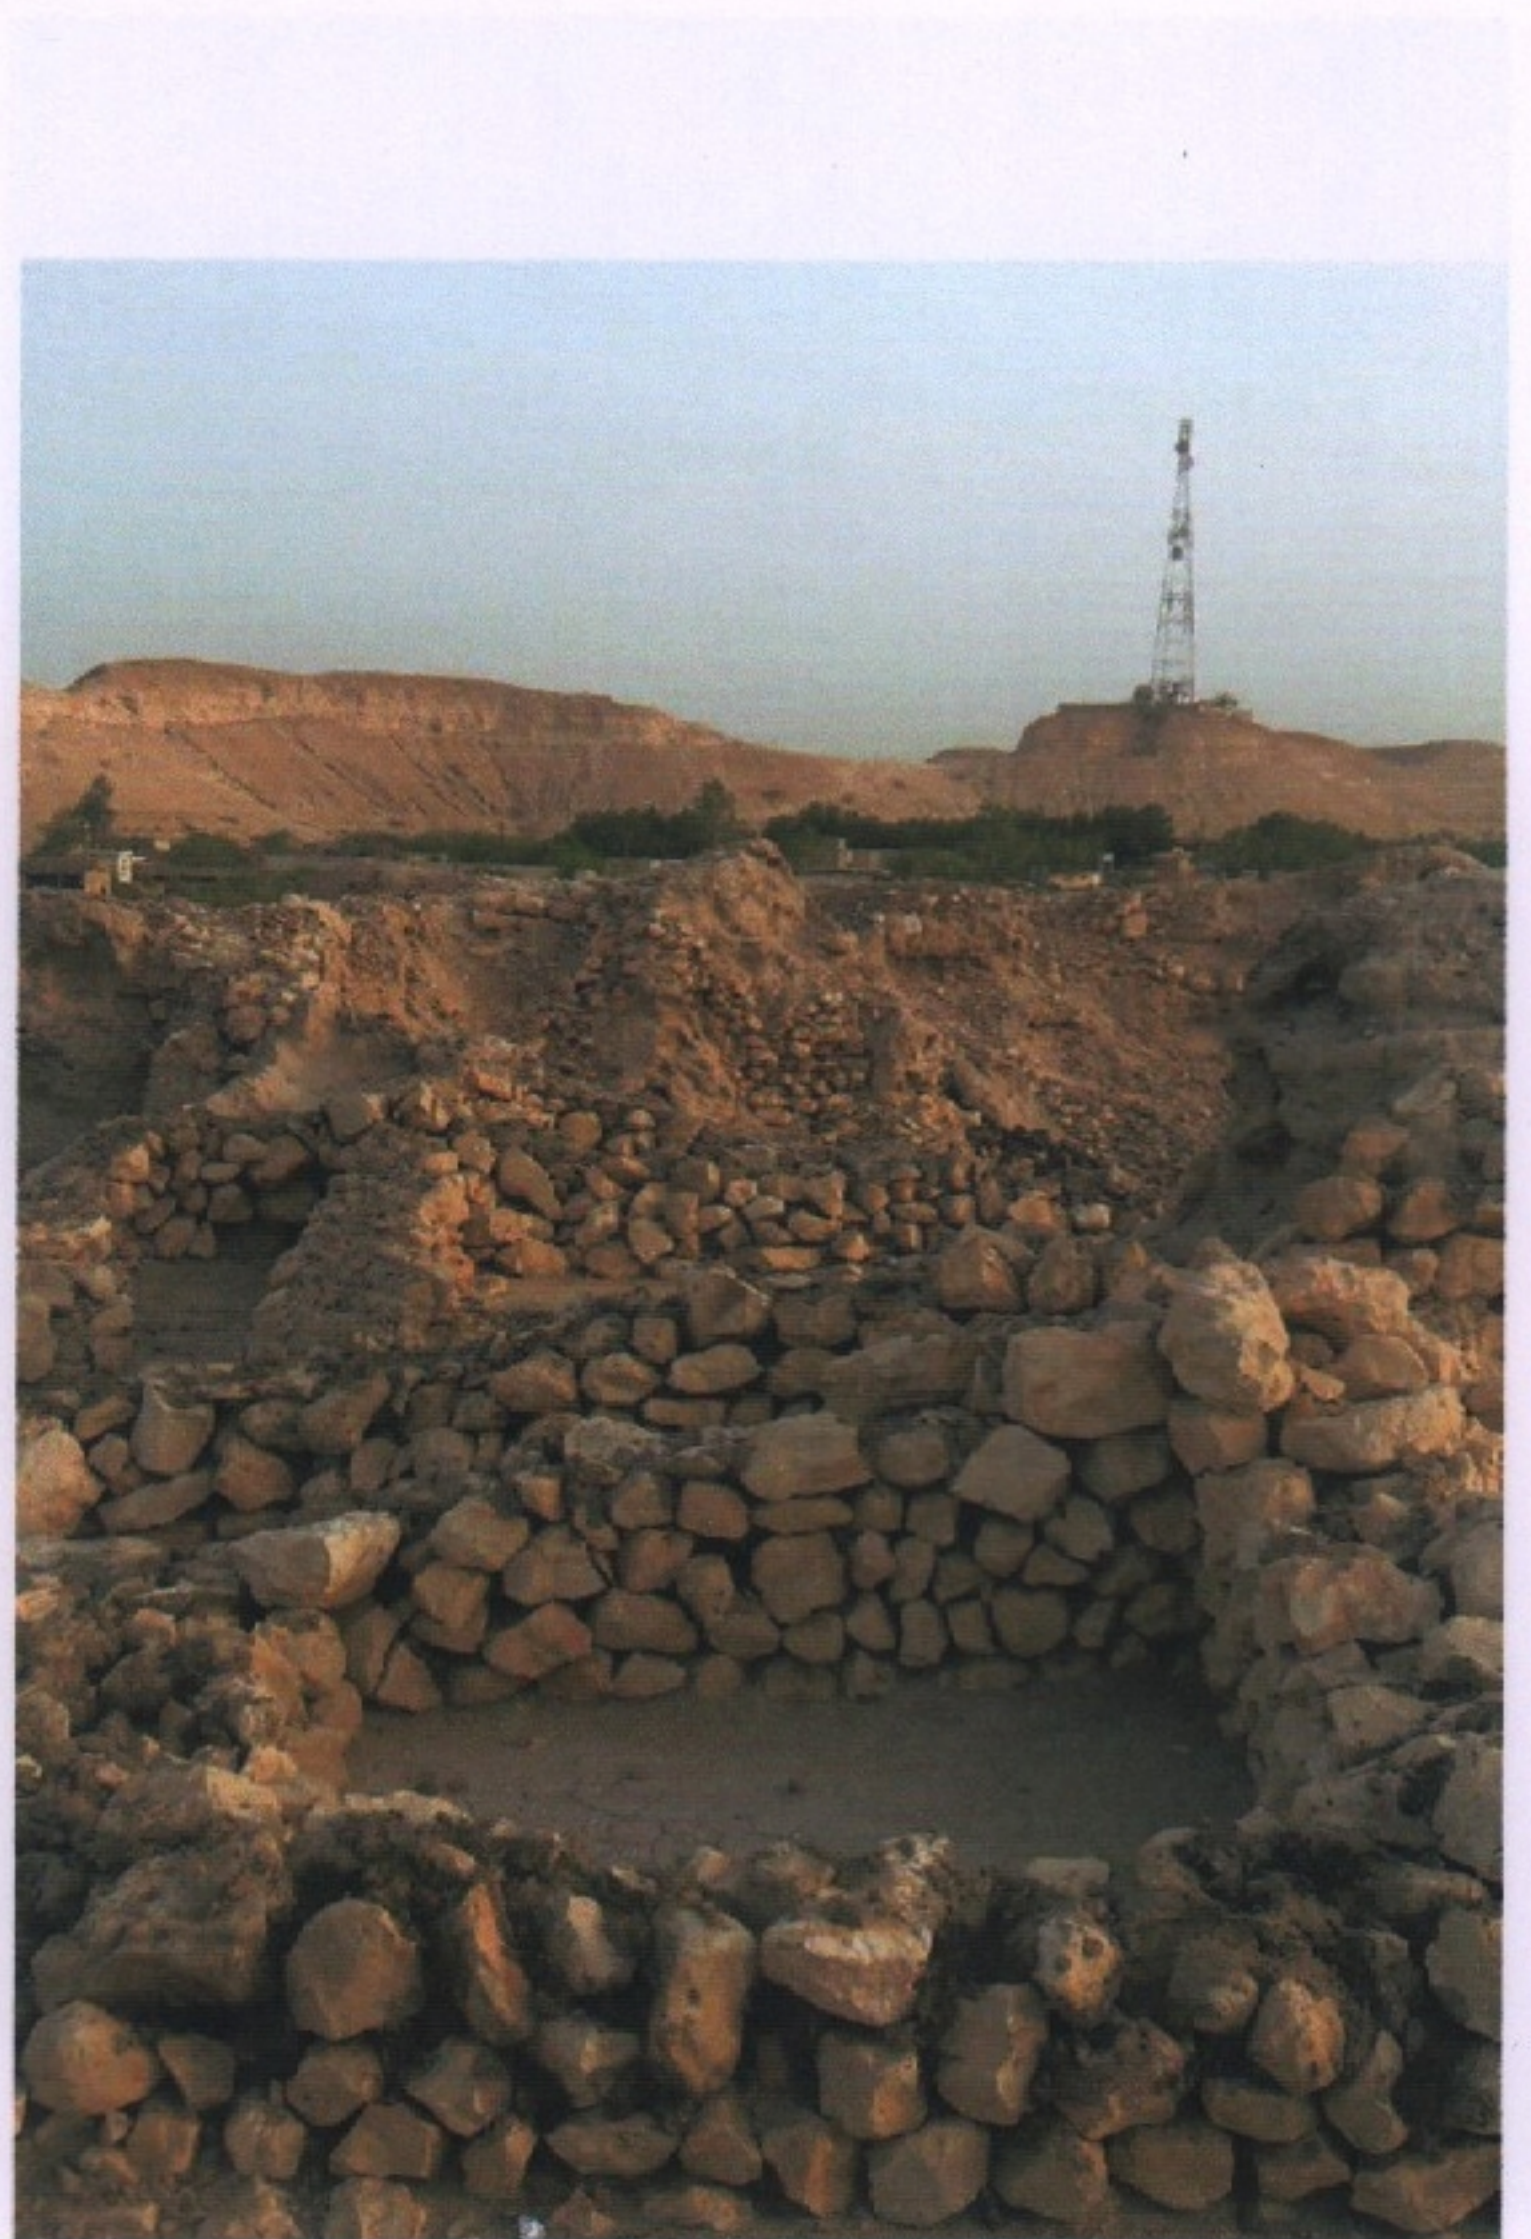
Some glimpsis of conservation, restoration work at Kotdiji remains.

The ruins constructed of undressed stone blocks laid in mud mortar exposed for many years after excavations faced both man made and environmental vandalism and long neglect. The stone boulders displaced from their original position and scattered all around the site. Due to the alarming and pathetic situation the conservation crew got help from the original reports and maps of excavations for relaying of stone boulders with mud mortar and some were relaid dry according to the excavation plans.

Restoration of fortification wall of Kotdiji ruins to the citadel which was built-in stone and mud revetted with mud and mud bricks have been completed. The wall fell into disuse in later Kotdijian times, when its top was occupied for habitation purposes. The average thickness of the walls is from two to three and half feet; their surviving height varies from one to four feet. Stone structural remains with

block of houses in citadel area were also reset including reassembling of Stone blocks used for to check floods from nearby stream were also carried out at pre Harrapan site of Kotdiji.
