RESTORATION AND CONSERVATION OF

KOTDIJI REMAINS

DISTRICT KHAIRPUR MIR'S.

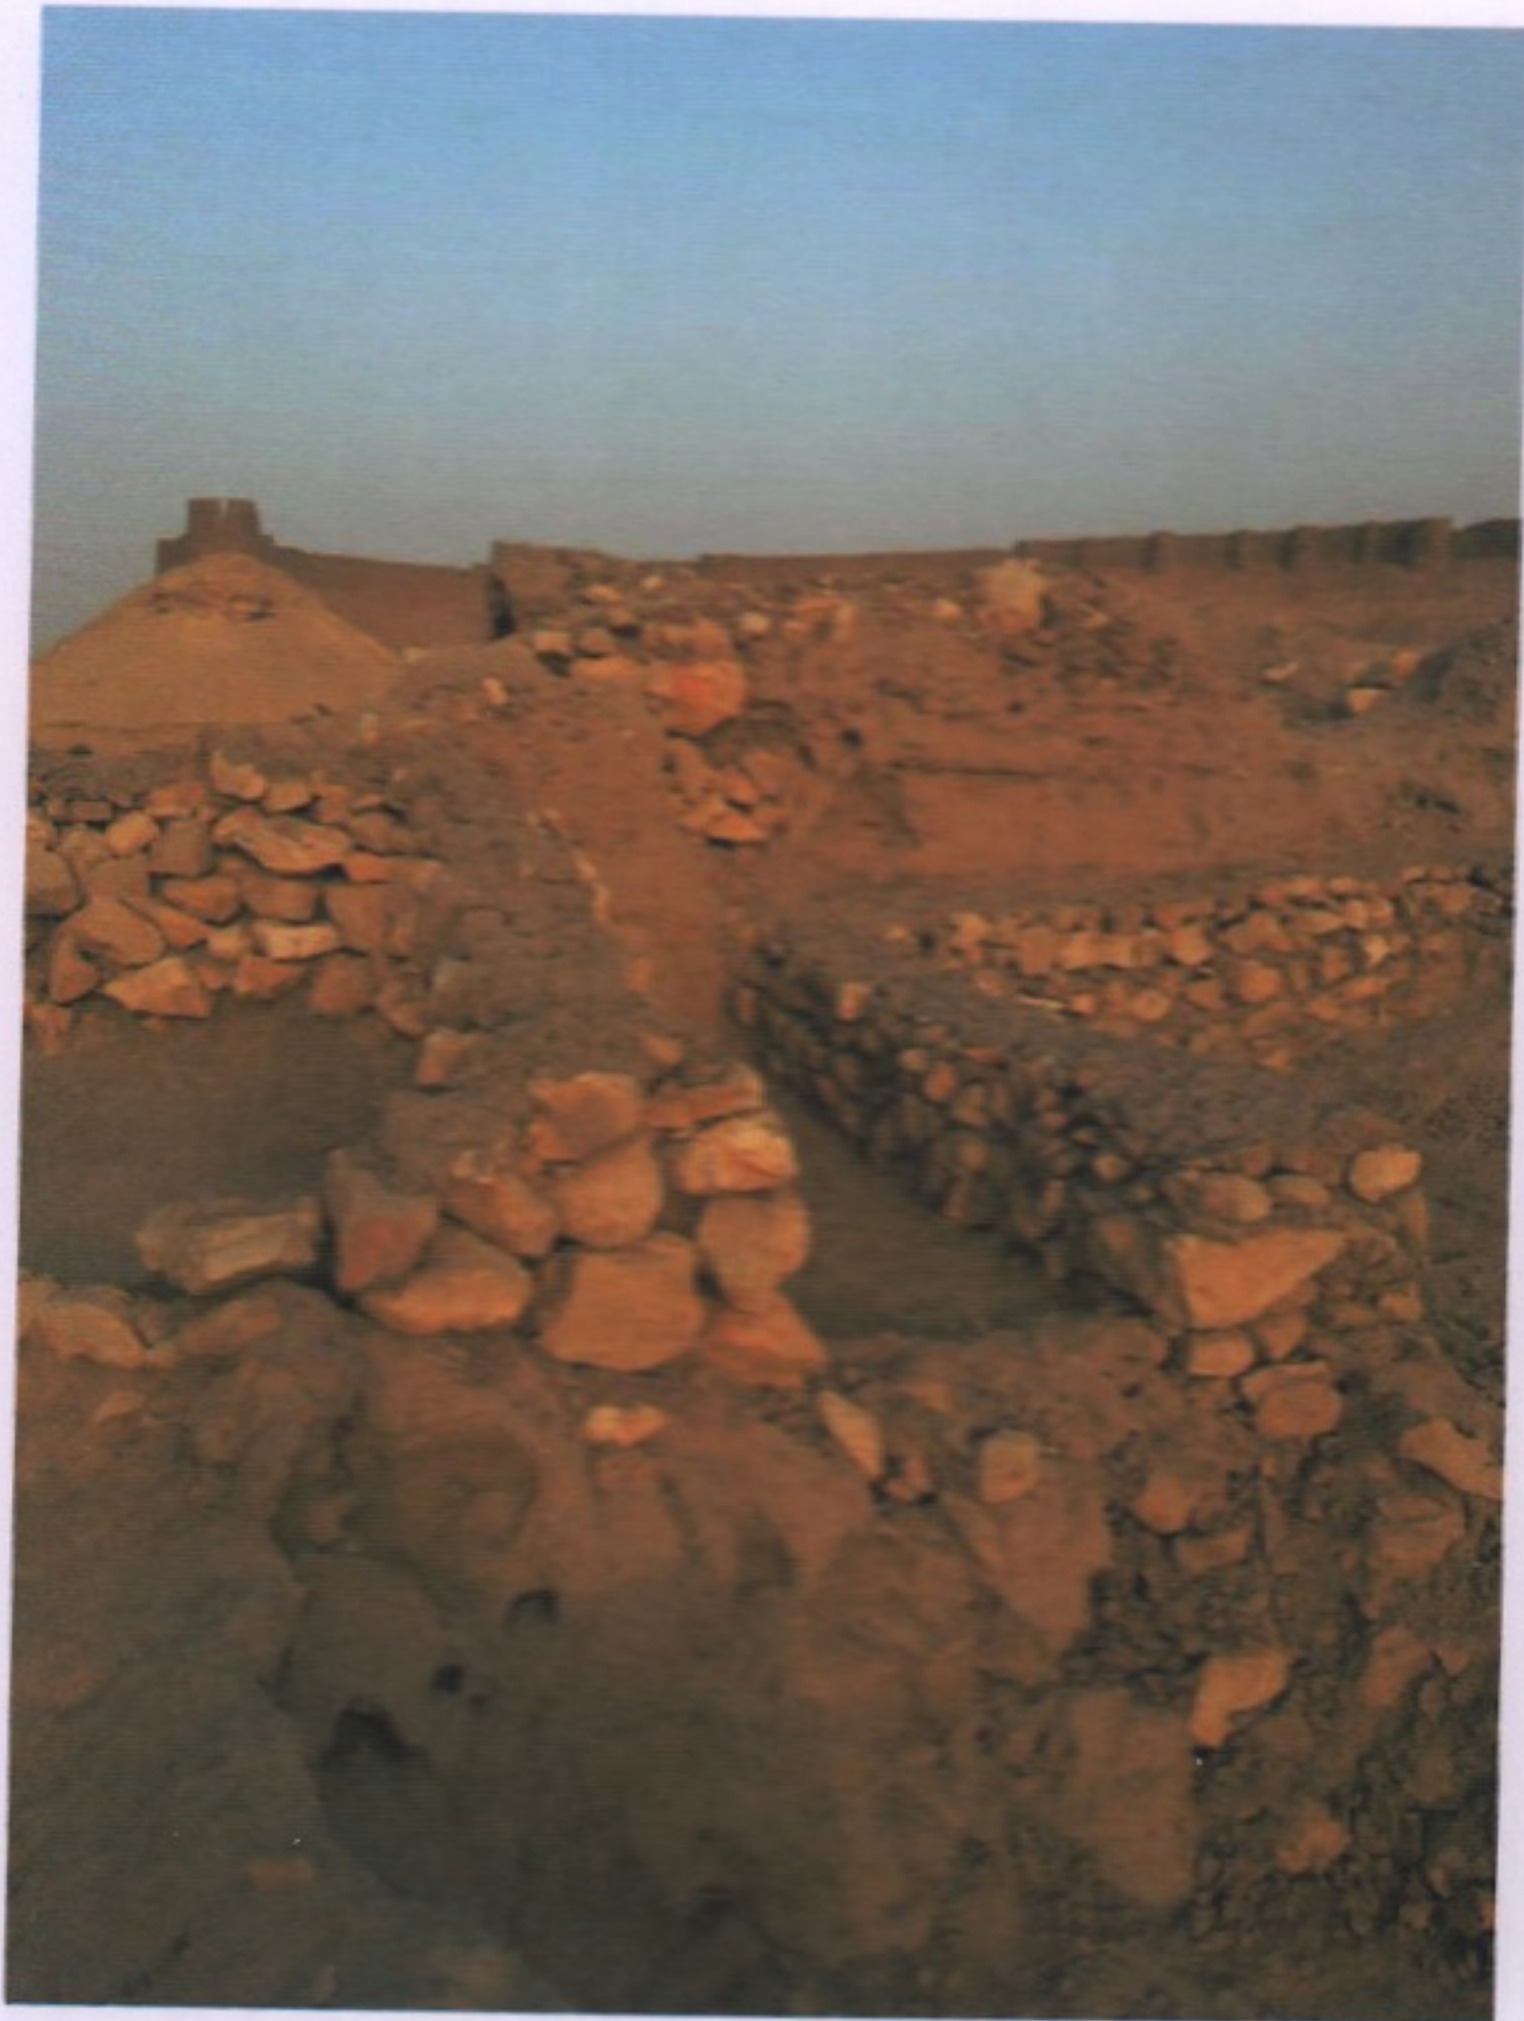
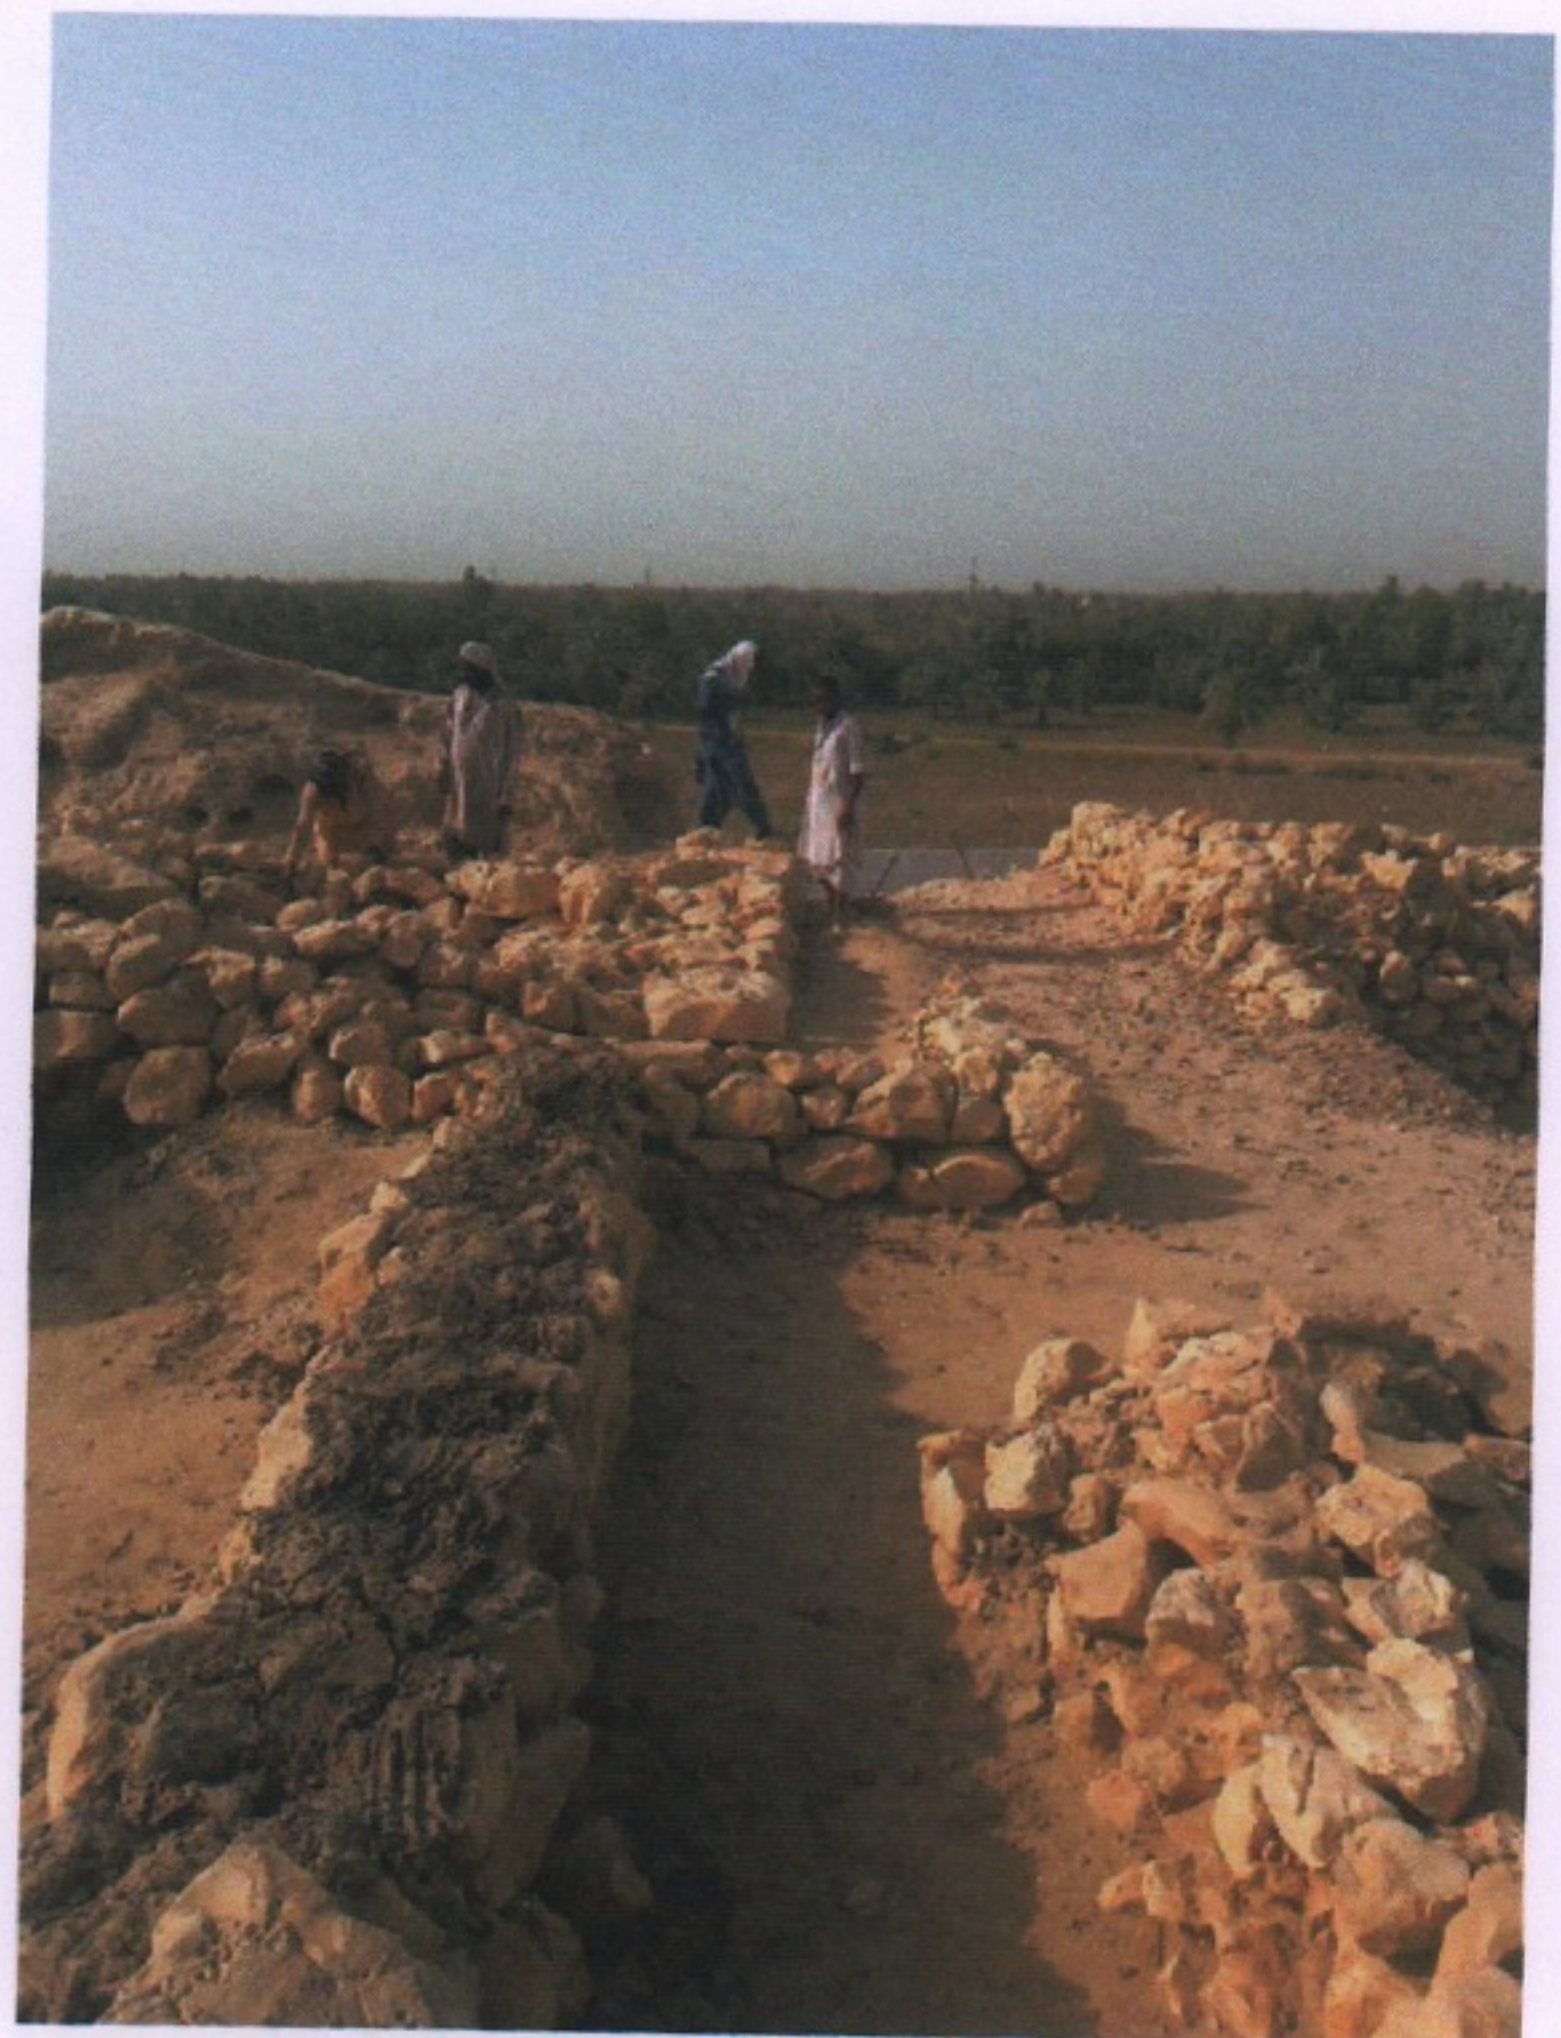
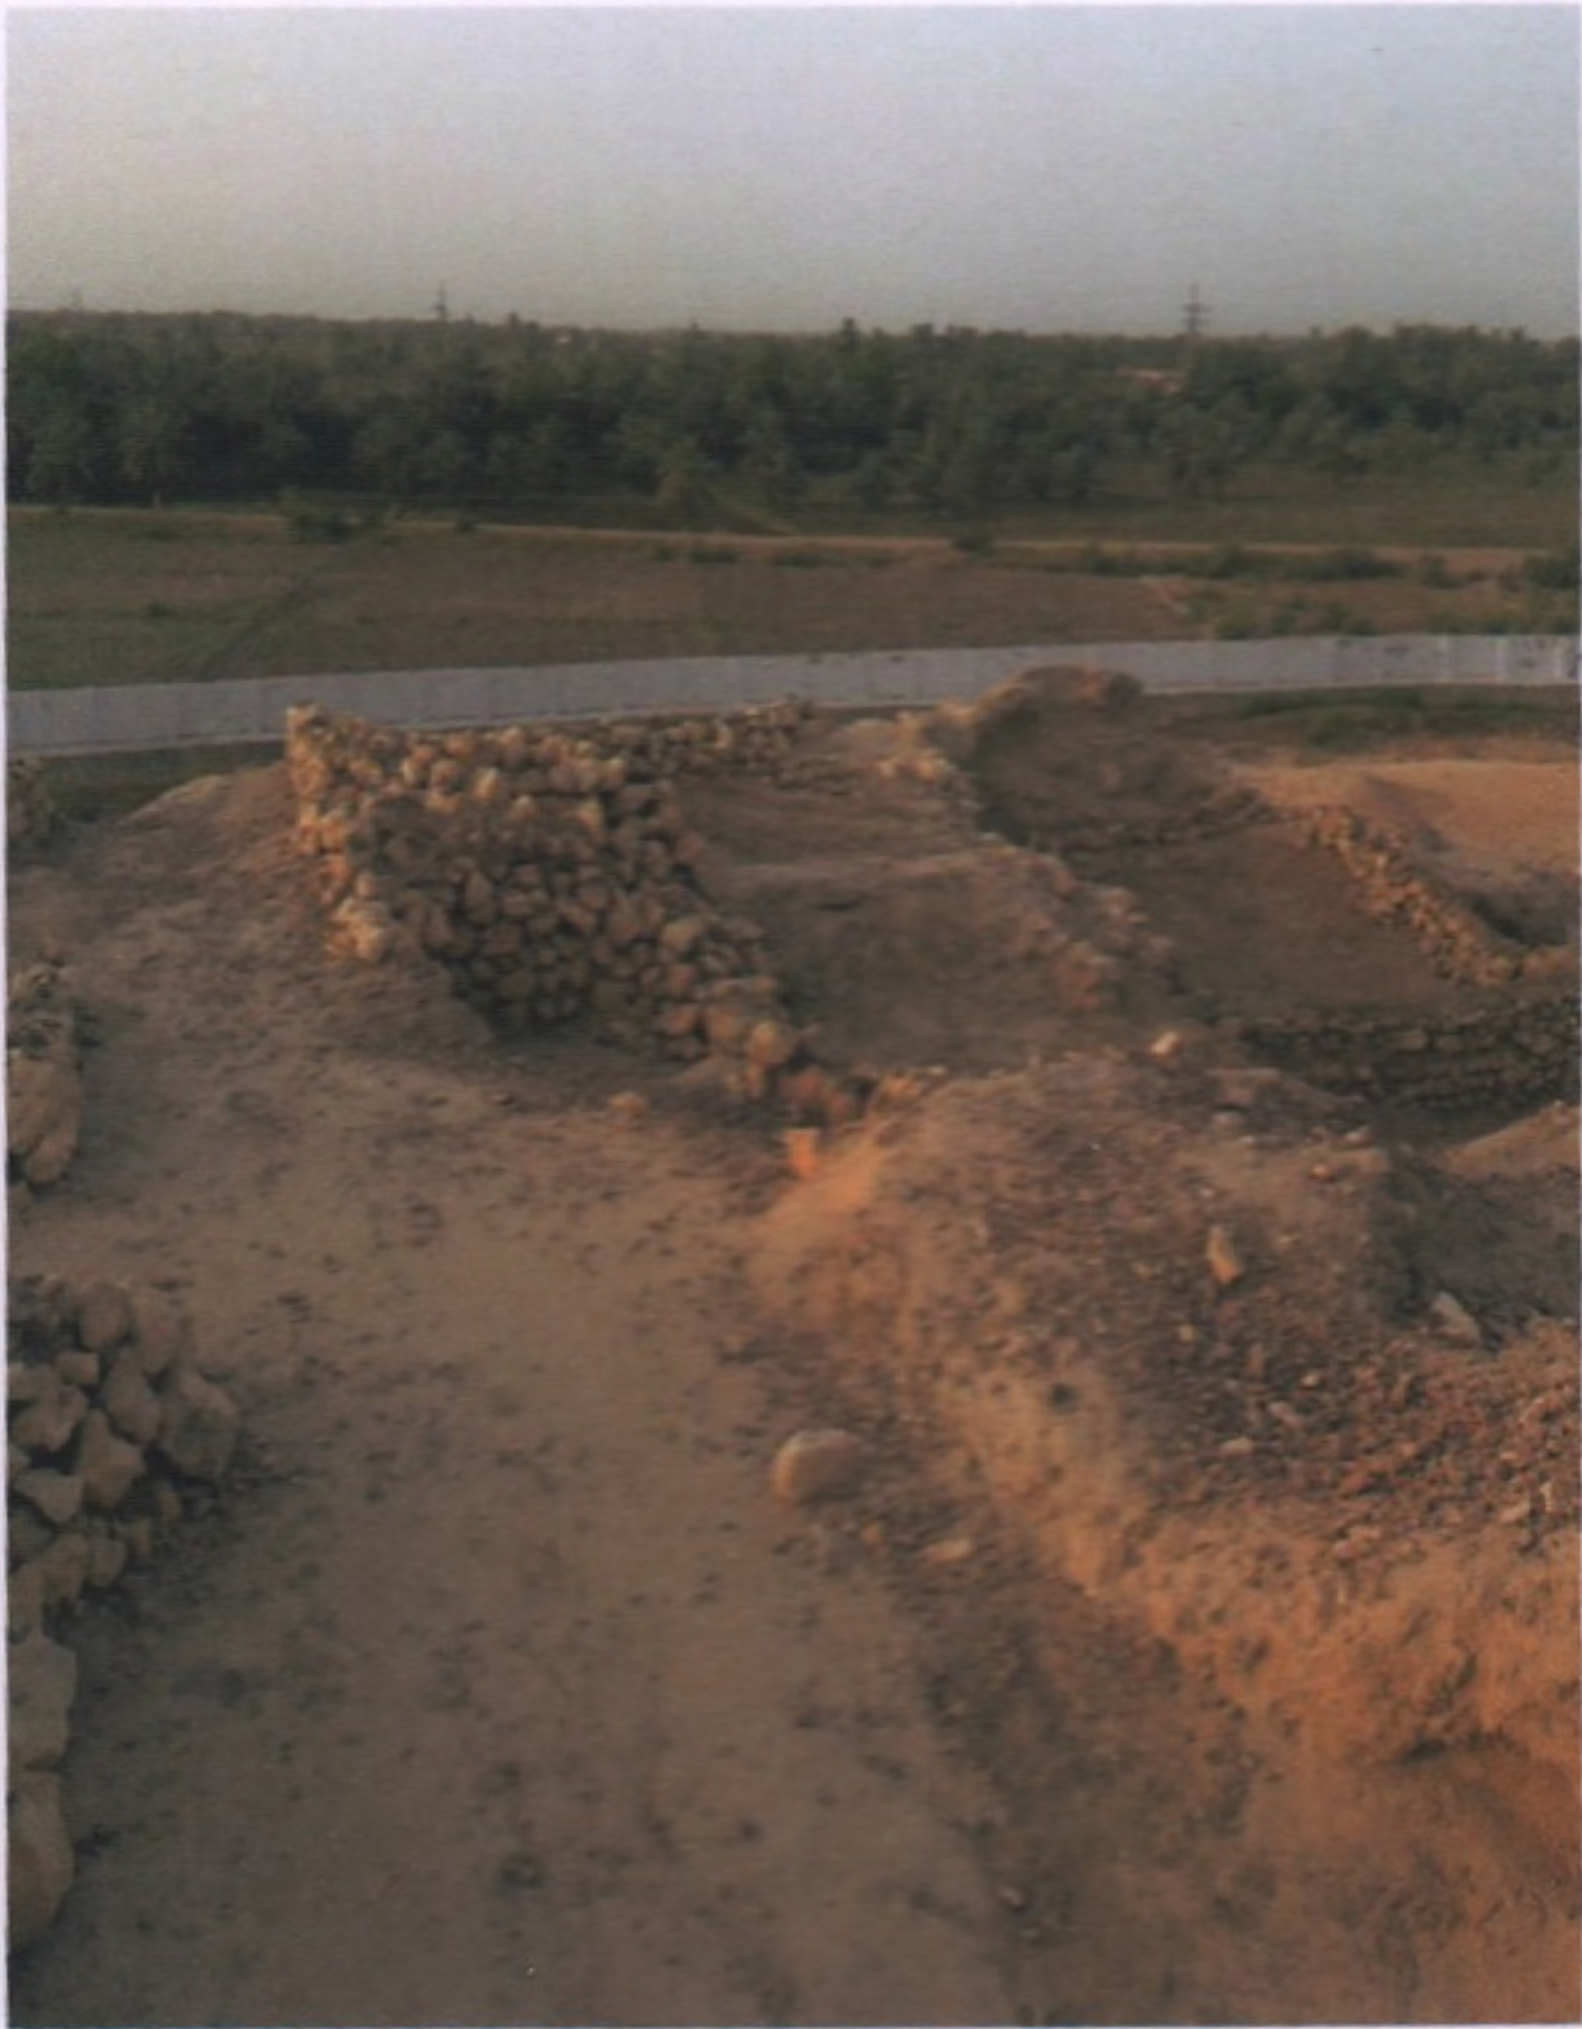
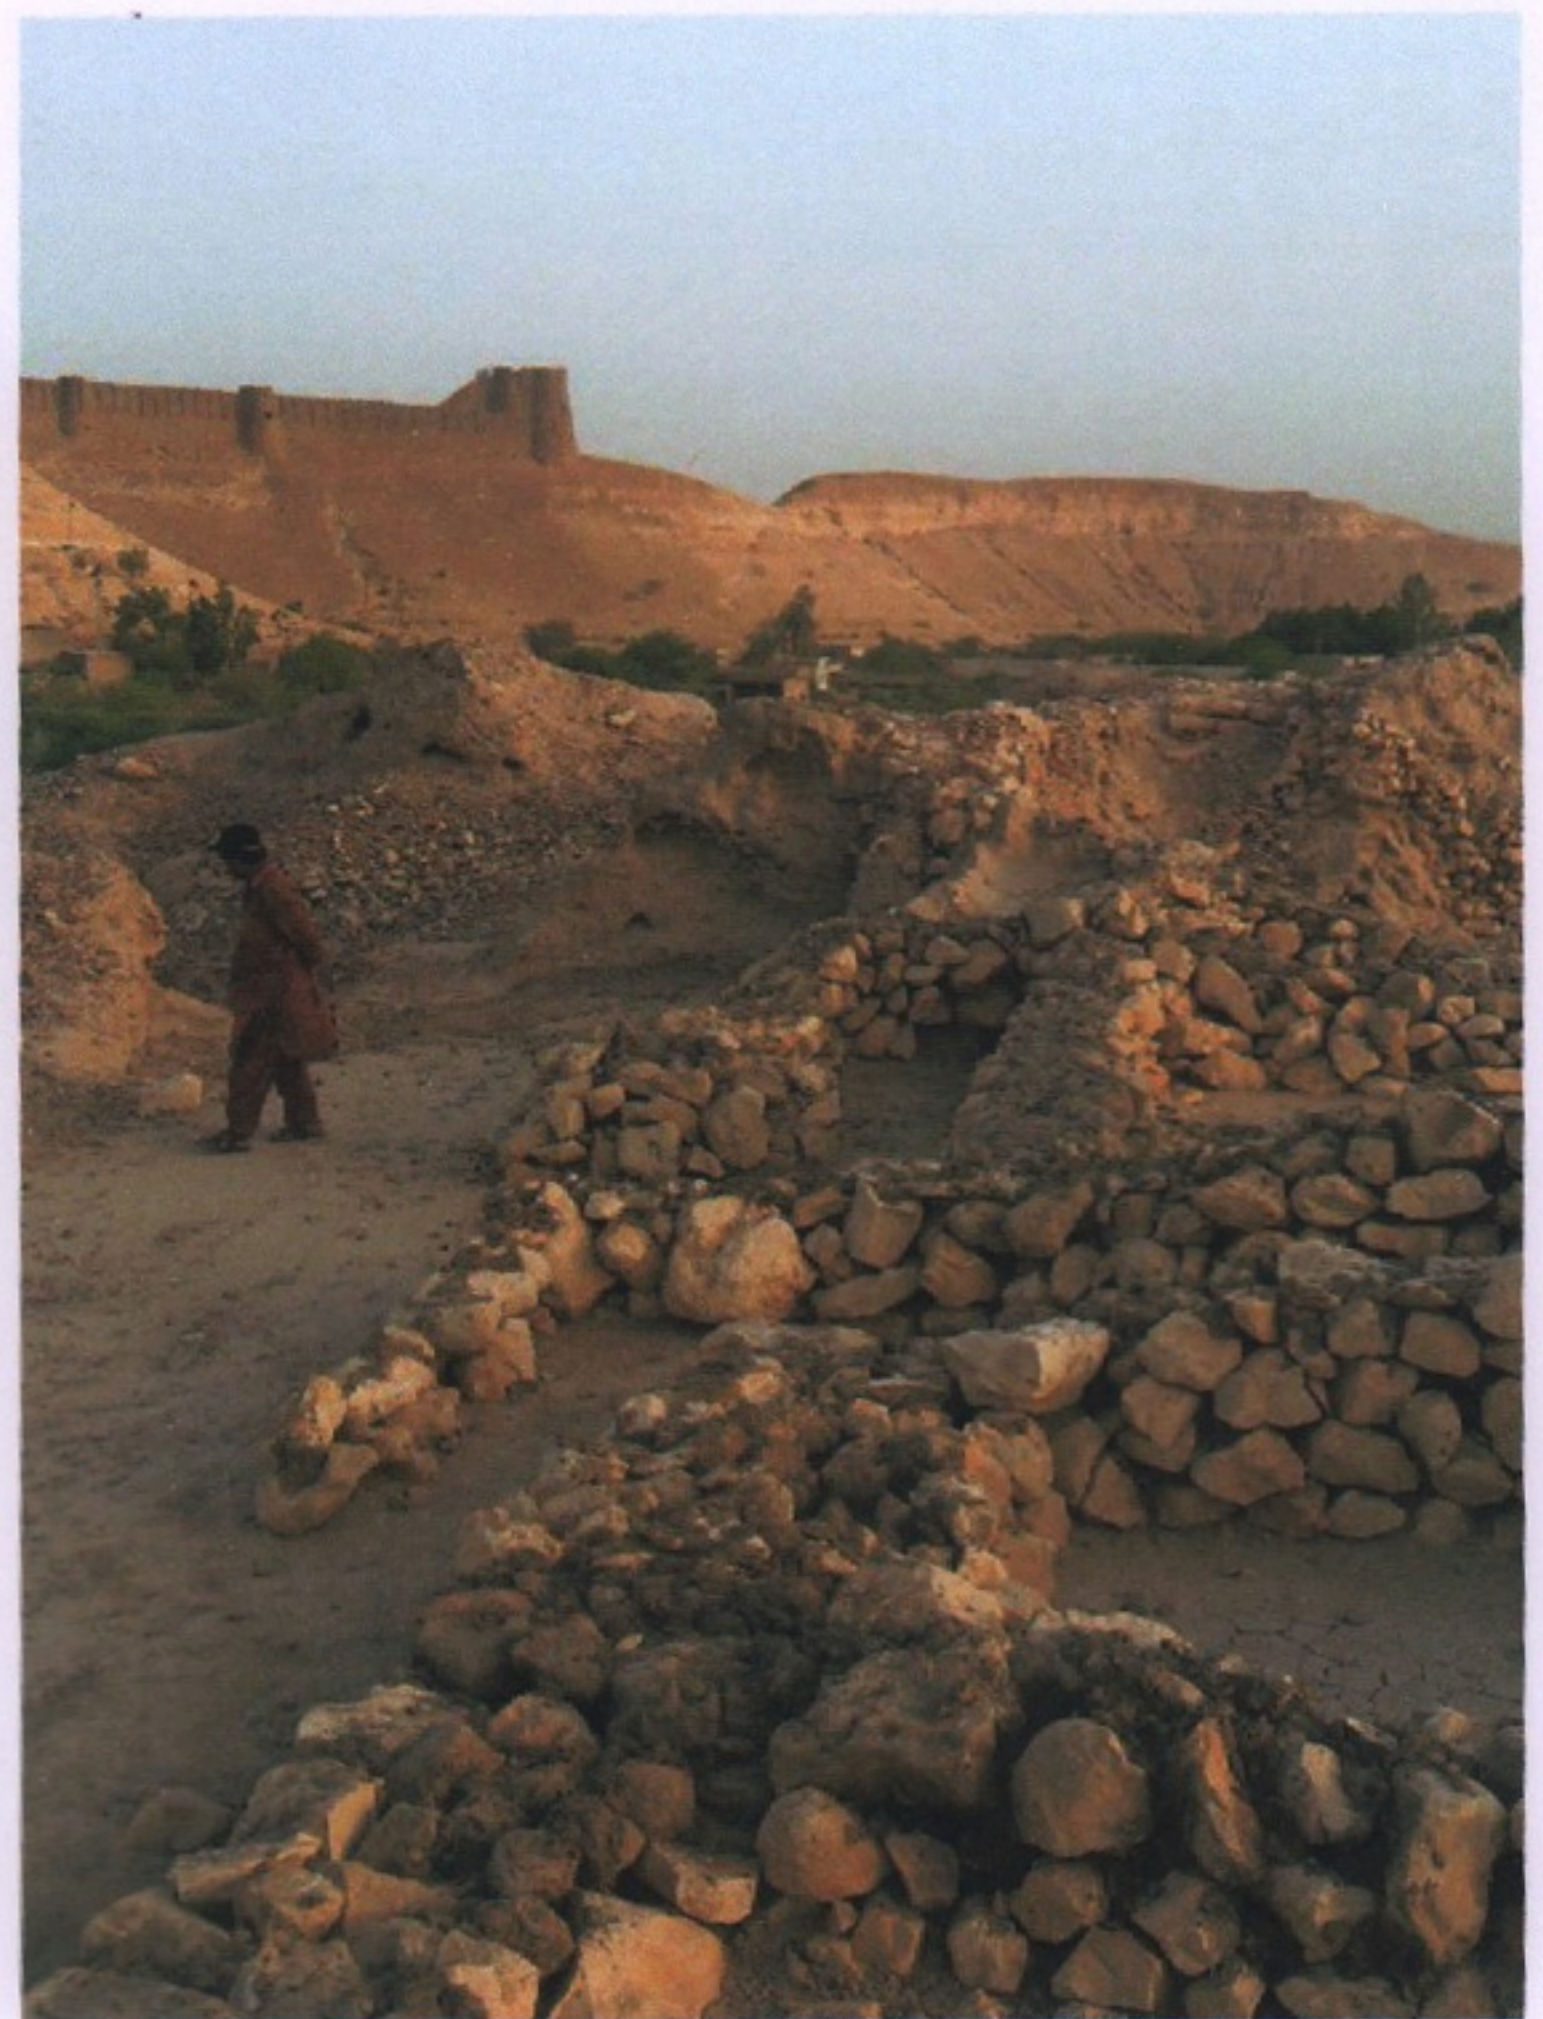
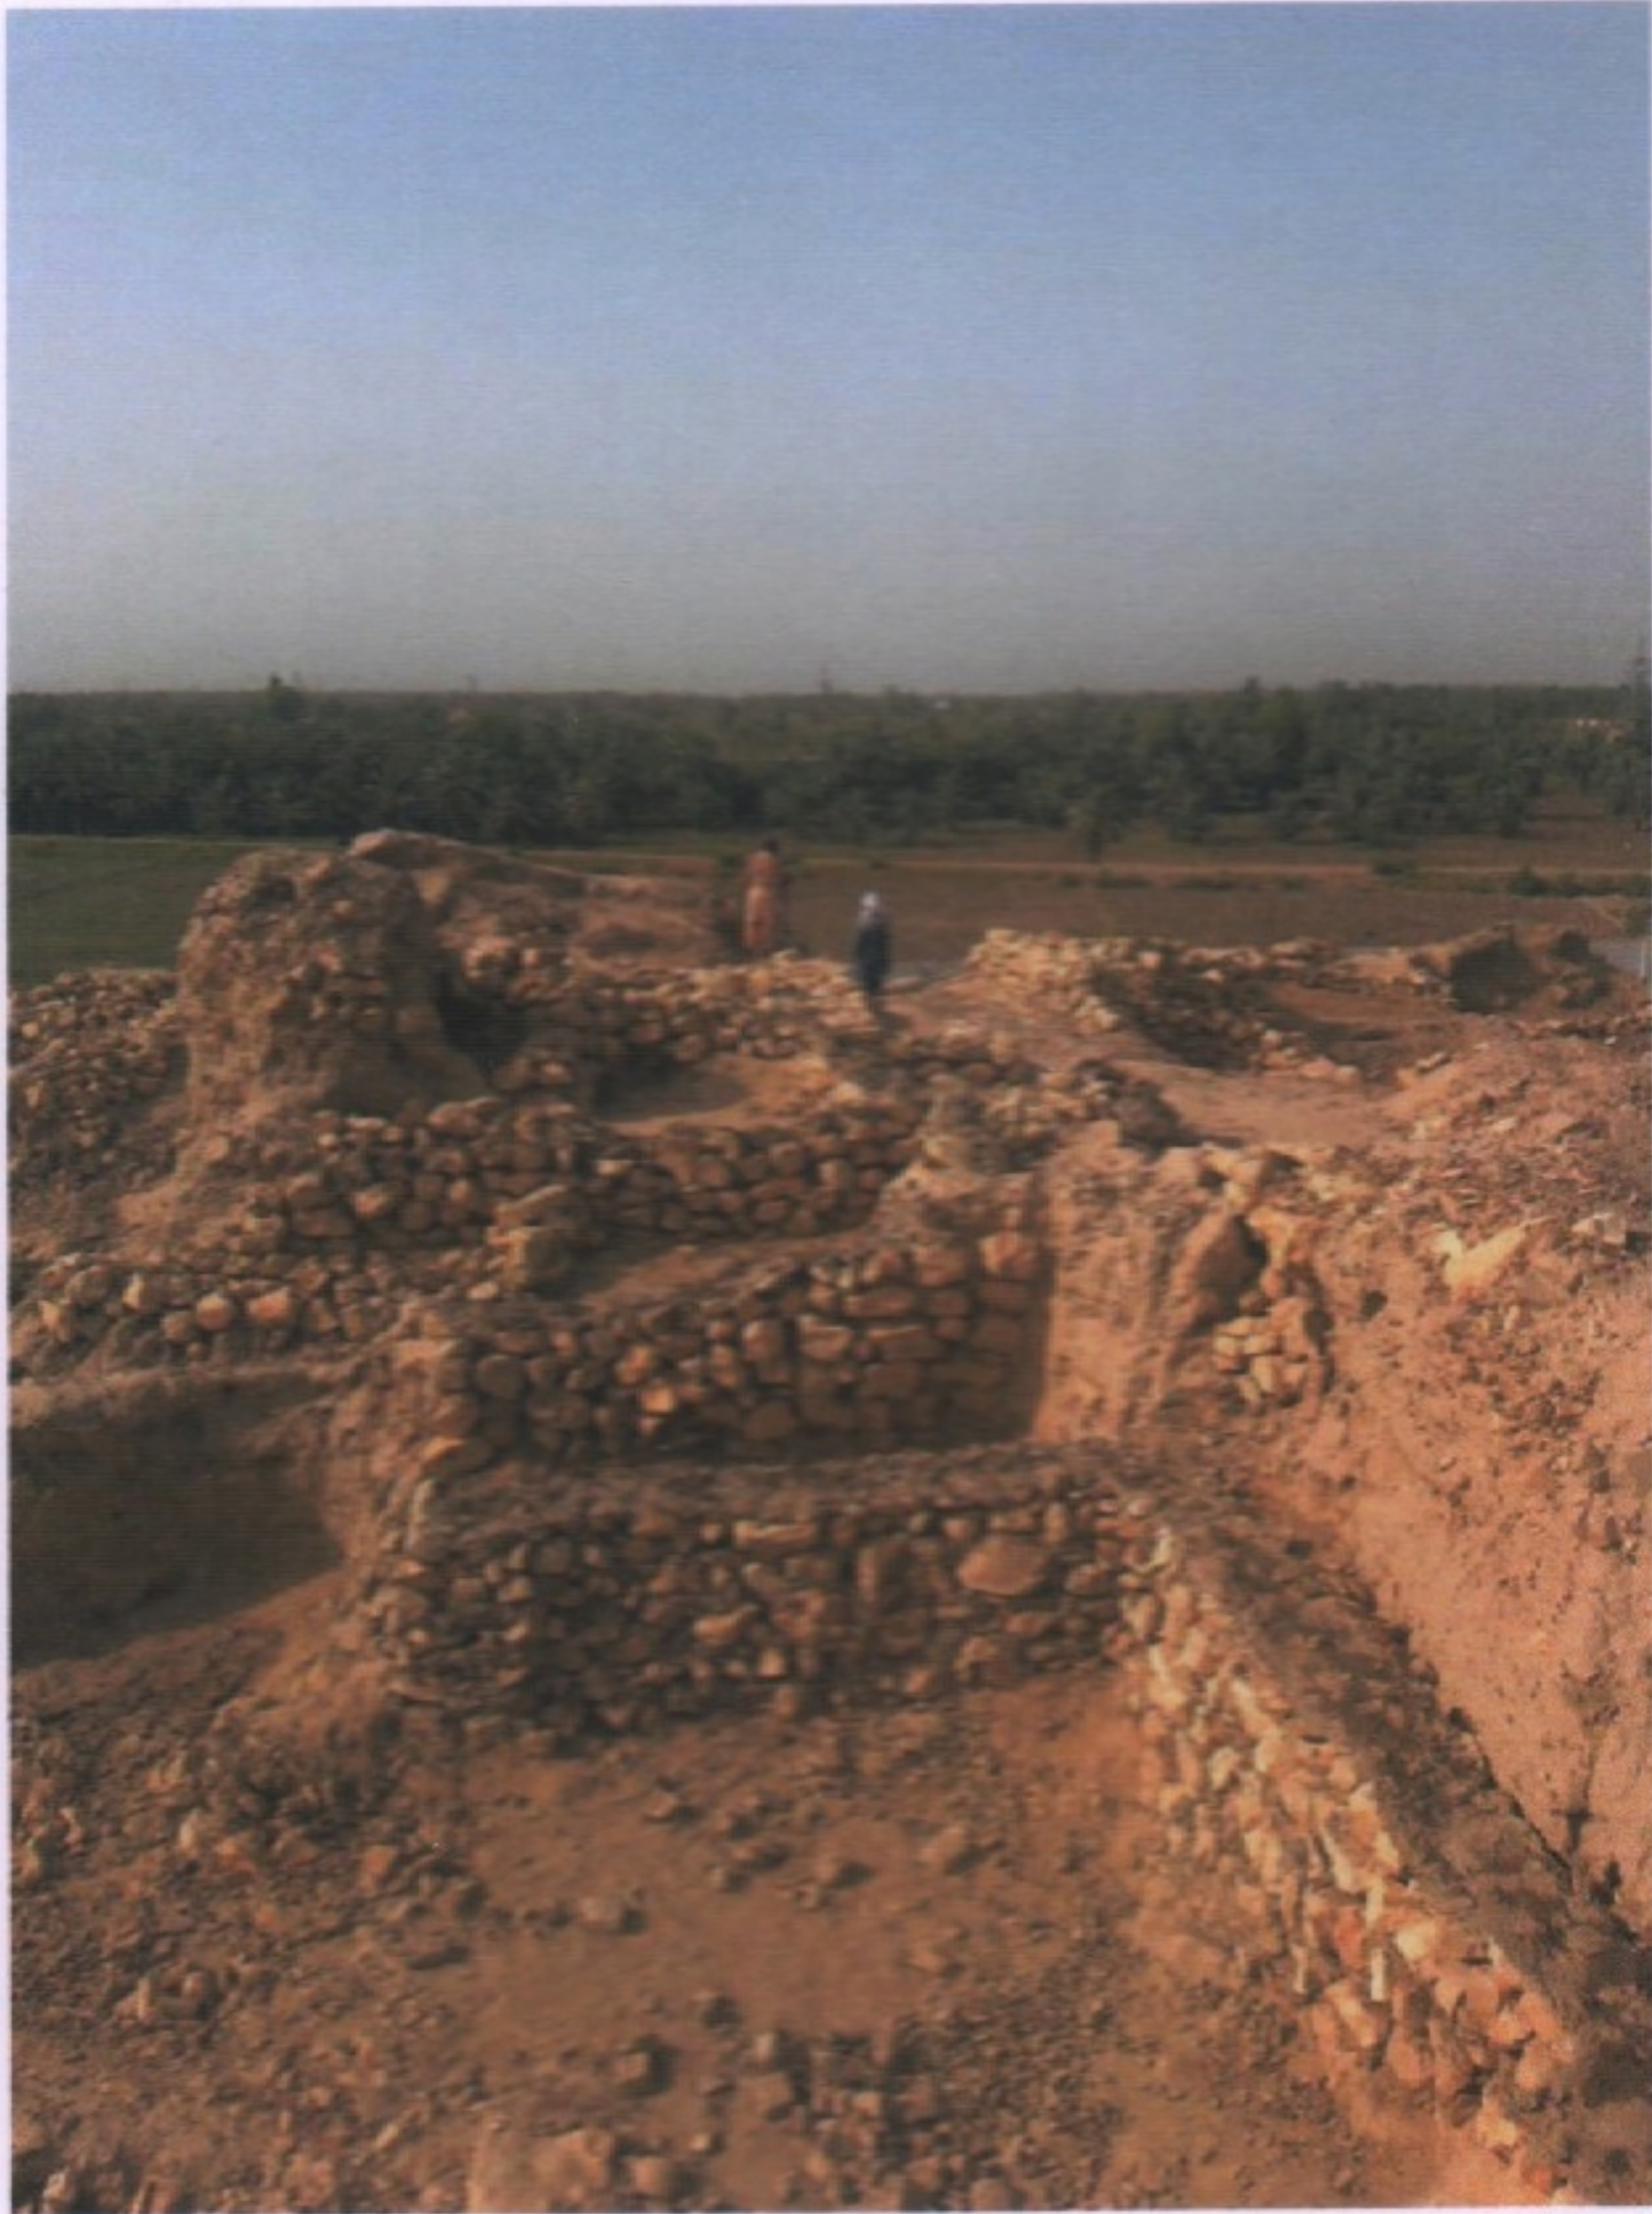
Some glimpsis of conservation, restoration work at Kotdiji remains.

The ruins constructed of undressed stone blocks laid in mud mortar exposed for many years after excavations faced both man made and environmental vandalism and long neglect. The stone boulders displaced from their original position and scattered all around the site. Due to the alarming and pathetic situation the conservation crew got help from the original reports and maps of excavations for relaying of stone boulders with mud mortar and some were relaid dry according to the excavation plans.

Restoration of fortification wall of Kotdiji ruins to the citadel which was built-in stone and mud revetted with mud and mud bricks have been completed. The wall fell into disuse in later Kotdijian times, when its top was occupied for habitation purposes. The average thickness of the walls is from two to three and half feet; their surviving height varies from one to four feet. Stone structural remains with

block of houses in citadel area were also reset including reassembling of Stone blocks used for to check floods from nearby stream were also carried out at pre Harrapan site of Kotdiji.
